**DEPARTMENT OF TRANSPORTATION**

Contract #: 04-0120F4Cty: SF/ALA Rte: 80 PM: 13.2/13.9File #: 69.28**WELDING INSPECTION REPORT****Resident Engineer:** Pursell, Gary**Address:** 333 Burma Road**City:** Oakland, CA 94607**Report No:** WIR-015082**Date Inspected:** 23-Jun-2010**Project Name:** SAS Superstructure**OSM Arrival Time:** 1900**Prime Contractor:** American Bridge/Fluor Enterprises, a JV**OSM Departure Time:** 700**Contractor:** Zhenhua Port Machinery Company, Ltd (ZPMC), Changxing Island **Location:** Shanghai, China**CWI Name:** See Below**CWI Present:** Yes No**Inspected CWI report:** Yes No N/A**Rod Oven in Use:** Yes No N/A**Electrode to specification:** Yes No N/A**Weld Procedures Followed:** Yes No N/A**Qualified Welders:** Yes No N/A**Verified Joint Fit-up:** Yes No N/A**Approved Drawings:** Yes No N/A**Approved WPS:** Yes No N/A**Delayed / Cancelled:** Yes No N/A**Bridge No:** 34-0006**Component:** OBG**Summary of Items Observed:**

## WELDING INSPECTION REPORT

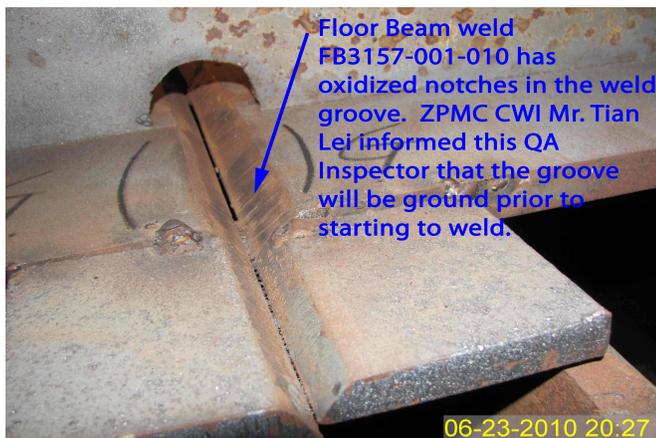
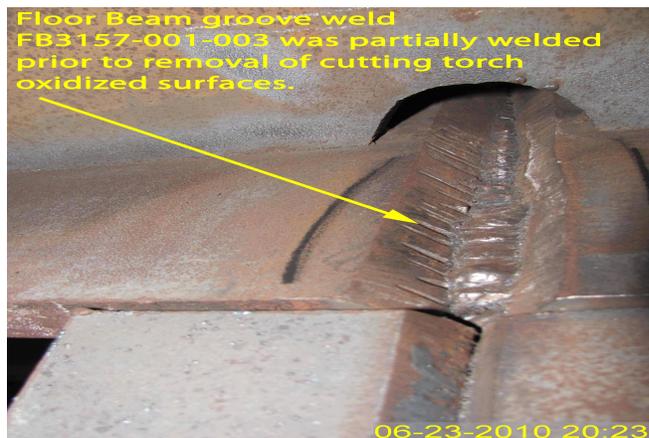
This QA Inspector observed floor beam groove weld FB3157-001-003 which is located close to where ZPMC welder Mr. Liu Ming had just completed welding appears to have a root pass weld in the bottom of the groove. This QA Inspector observed the weld bevels appear to have been made with an acetylene torch and there are deep oxide grooves in the weld bevel surfaces where weld material has been deposited. This QA Inspector showed this area to ZPMC CWI Mr. Tian Lei who informed this QA Inspector that he will issue a repair document to remove the weld and grind the bevels prior to additional welding. This QA Inspector observed floor beam groove weld FB3157-001-010 has not been welded and the weld grooves have similar grooves. Mr. Tian Lei marked this weld as needing to be ground prior to commencement of welding. See the photographs below for additional information.
