DEPARTMENT OF TRANSPORTATION

Contract #: 04-0120F4Cty: SF/ALA Rte: 80 PM: 13.2/13.9File #: 69.28**WELDING INSPECTION REPORT****Resident Engineer:** Pursell, Gary**Address:** 333 Burma Road**City:** Oakland, CA 94607**Report No:** WIR-015119**Date Inspected:** 16-Jun-2010**Project Name:** SAS Superstructure**OSM Arrival Time:** 700**Prime Contractor:** American Bridge/Fluor Enterprises, a JV**OSM Departure Time:** 1900**Contractor:** Zhenhua Port Machinery Company, Ltd (ZPMC), Changxing Island **Location:** Shanghai, China**CWI Name:** Mr. Gong Wei/Xu Tao**CWI Present:** Yes No**Inspected CWI report:** Yes No N/A**Rod Oven in Use:** Yes No N/A**Electrode to specification:** Yes No N/A**Weld Procedures Followed:** Yes No N/A**Qualified Welders:** Yes No N/A**Verified Joint Fit-up:** Yes No N/A**Approved Drawings:** Yes No N/A**Approved WPS:** Yes No N/A**Delayed / Cancelled:** Yes No N/A**Bridge No:** 34-0006**Component:** OBG**Summary of Items Observed:**

WELDING INSPECTION REPORT

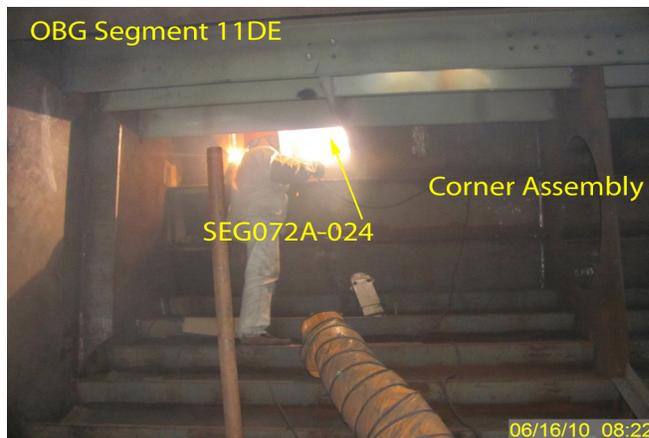
FCAW in the 4F position for the OBG Bike Path BK004A, weld No. BK004A4-005-023. The welder is identified as #0500909. ZPMC CWI is identified as Mr. Xu Tao. The welding variables recorded by QC appear to comply with WPS-B-T-2134. Please see the attached picture.
