DEPARTMENT OF TRANSPORTATION

Quality Assurance and Source Inspection

Contract #: 04-0120F4Cty: SF/ALA Rte: 80 PM: 13.2/13.9File #: 69.28**WELDING INSPECTION REPORT****Resident Engineer:** Pursell, Gary**Address:** 333 Burma Road**City:** Oakland, CA 94607**Report No:** WIR-015330**Date Inspected:** 30-Jun-2010**Project Name:** SAS Superstructure**OSM Arrival Time:** 700**Prime Contractor:** American Bridge/Fluor Enterprises, a JV**OSM Departure Time:** 1900**Contractor:** Zhenhua Port Machinery Company, Ltd (ZPMC), Changxing Island **Location:** Shanghai, China**CWI Name:** Mr. Gao Zhi Chun**CWI Present:** Yes No**Inspected CWI report:** Yes No N/A**Rod Oven in Use:** Yes No N/A**Electrode to specification:** Yes No N/A**Weld Procedures Followed:** Yes No N/A**Qualified Welders:** Yes No N/A**Verified Joint Fit-up:** Yes No N/A**Approved Drawings:** Yes No N/A**Approved WPS:** Yes No N/A**Delayed / Cancelled:** Yes No N/A**Bridge No:** 34-0006**Component:** Tower**Summary of Items Observed:**

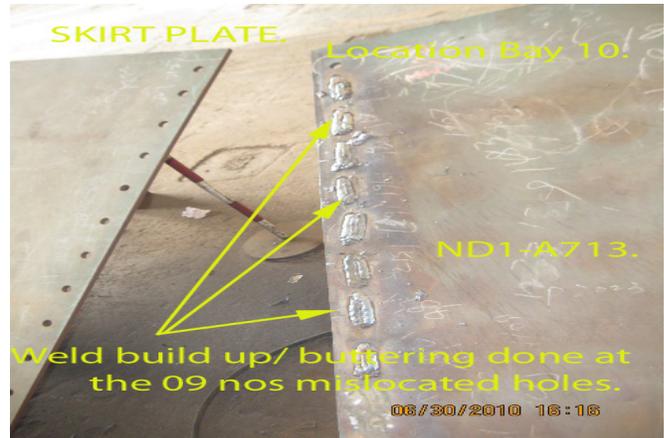
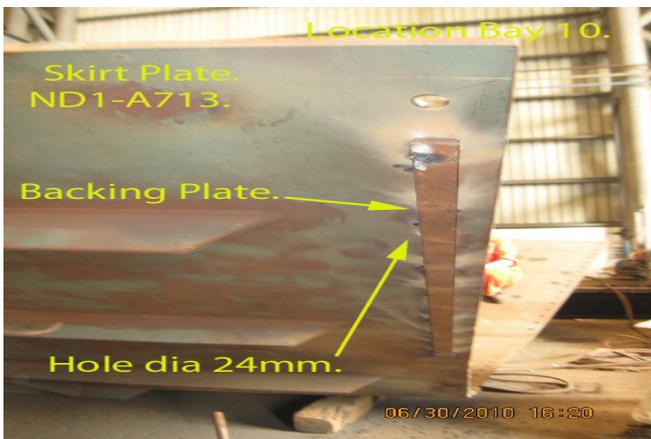
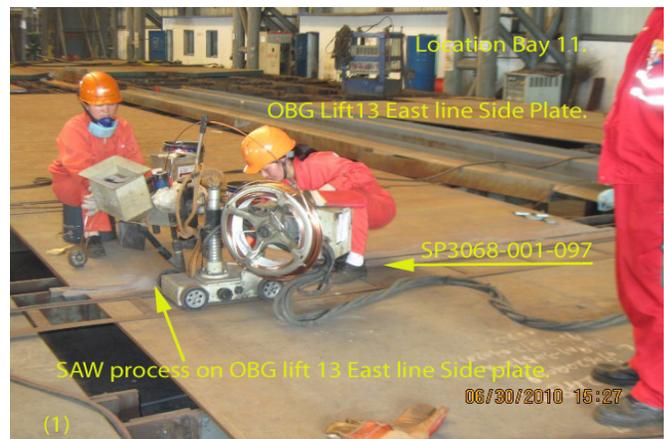
This QA Inspector observed ZPMC qualified welding personnel identified as 053870 Perform Flux Core Arc Welding (FCAW) on Skirt plate mis located holes 9 nos. Plate identified as ND1-A713. ZPMC QC Identified as Yu Zhi Lai, with temporary welding repair report WRR-T-WR3456. The welding parameters as measured using QC's calibrated instrument appeared to be in general compliance with WPS-345-FCAW-3G (3F)-Repair. For more information see below attached pictures.
