Contract #: 04-0120F4Cty: SF/ALA Rte: 80 PM: 13.2/13.9File #: 69.28**WELDING INSPECTION REPORT****Resident Engineer:** Pursell, Gary**Address:** 333 Burma Road**City:** Oakland, CA 94607**Report No:** WIR-015400**Date Inspected:** 23-Jun-2010**Project Name:** SAS Superstructure**OSM Arrival Time:** 700**Prime Contractor:** American Bridge/Fluor Enterprises, a JV**OSM Departure Time:** 1900**Contractor:** Zhenhua Port Machinery Company, Ltd (ZPMC), Changxing Island **Location:** Shanghai, China**CWI Name:** Li Yang**CWI Present:** Yes No**Inspected CWI report:** Yes No N/A**Rod Oven in Use:** Yes No N/A**Electrode to specification:** Yes No N/A**Weld Procedures Followed:** Yes No N/A**Qualified Welders:** Yes No N/A**Verified Joint Fit-up:** Yes No N/A**Approved Drawings:** Yes No N/A**Approved WPS:** Yes No N/A**Delayed / Cancelled:** Yes No N/A**Bridge No:** 34-0006**Component:** OBG Segment**Summary of Items Observed:**

WELDING INSPECTION REPORT

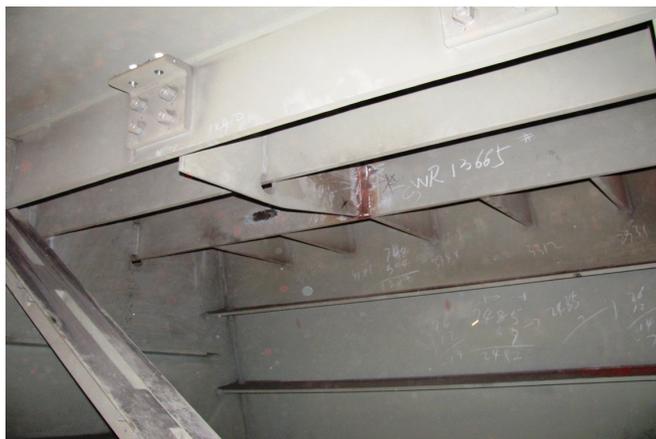
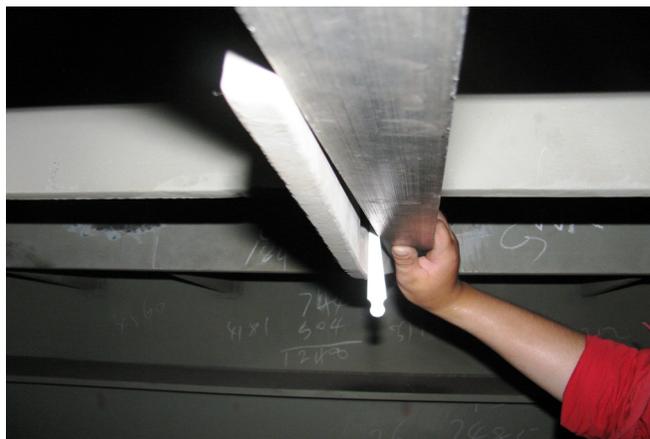
Welding of weld joint – 026 located on PCMK BP125-001, T-Rib CJP weld joints segment 9BE and 9CE. Welder is identified as 220066. ZPMC CWI is identified as Li Yang. The welding variables recorded by QC appeared to comply with the WPS-B-T-2233-B-U2-F.

Welding of weld joint – 026 located on PCMK BP071-001, T-Rib CJP weld joints segment 9BE and 9CE. Welder is identified as 222396. ZPMC CWI is identified as Li Yang. The welding variables recorded by QC appeared to comply with the WPS-B-T-2233-B-U2-F.
