**DEPARTMENT OF TRANSPORTATION**

Contract #: 04-0120F4Cty: SF/ALA Rte: 80 PM: 13.2/13.9File #: 69.28**WELDING INSPECTION REPORT****Resident Engineer:** Pursell, Gary**Address:** 333 Burma Road**City:** Oakland, CA 94607**Report No:** WIR-015415**Date Inspected:** 29-Jun-2010**Project Name:** SAS Superstructure**OSM Arrival Time:** 700**Prime Contractor:** American Bridge/Fluor Enterprises, a JV**OSM Departure Time:** 1900**Contractor:** Zhenhua Port Machinery Company, Ltd (ZPMC), Changxing Island **Location:** Shanghai, China**CWI Name:****CWI Present:**

**Bridge No:** 34-0006**Component:** OBG Trial Assembly**Summary of Items Observed:**

Orthotropic Box Girder (OBG) Trial Assembly Areas

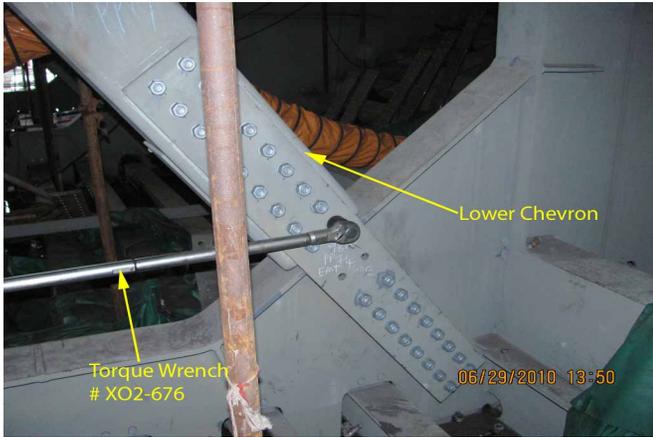
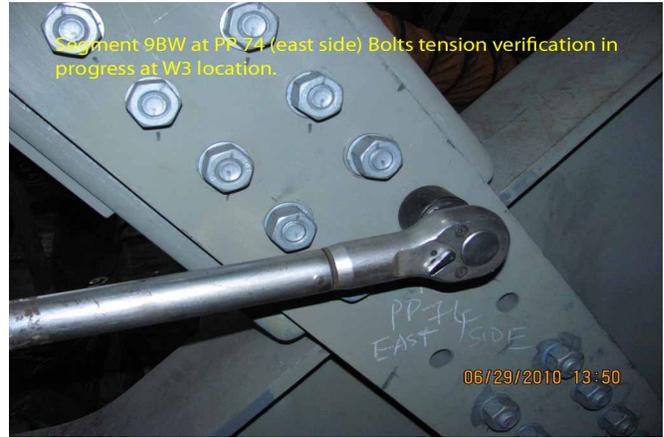
This Quality Assurance (QA) Inspector witnessed final tension verification for Lower Chevron (North and South side) at Panel Point (PP) 72 and PP 73 for Segment 9AW. Inspected 10% on a random basis and found the tension to be in general compliance. Inspection was performed against the Notification No. 00401 Dated June 29, 2010.

This Quality Assurance (QA) Inspector witnessed final tension verification for Lower Chevron (North and South side) at Panel Point (PP) 74, PP 75 and PP 76 for Segment 9BW. Inspected 10% on a random basis and found the tension to be in general compliance. Inspection was performed against the Notification No. 00401 Dated June 29, 2010.

Please refer the pictures attached for more comprehensive details.
