**DEPARTMENT OF TRANSPORTATION**

Contract #: 04-0120F4Cty: SF/ALA Rte: 80 PM: 13.2/13.9File #: 69.28**WELDING INSPECTION REPORT****Resident Engineer:** Pursell, Gary**Address:** 333 Burma Road**City:** Oakland, CA 94607**Report No:** WIR-015424**Date Inspected:** 29-Jun-2010**Project Name:** SAS Superstructure**OSM Arrival Time:** 1900**Prime Contractor:** American Bridge/Fluor Enterprises, a JV**OSM Departure Time:** 700**Contractor:** Zhenhua Port Machinery Company, Ltd (ZPMC), Changxing Island **Location:** Shanghai, China**CWI Name:** See Below**CWI Present:** Yes No**Inspected CWI report:** Yes No N/A**Rod Oven in Use:** Yes No N/A**Electrode to specification:** Yes No N/A**Weld Procedures Followed:** Yes No N/A**Qualified Welders:** Yes No N/A**Verified Joint Fit-up:** Yes No N/A**Approved Drawings:** Yes No N/A**Approved WPS:** Yes No N/A**Delayed / Cancelled:** Yes No N/A**Bridge No:** 34-0006**Component:** OBG**Summary of Items Observed:**

**OBG Segment Trial Assembly**

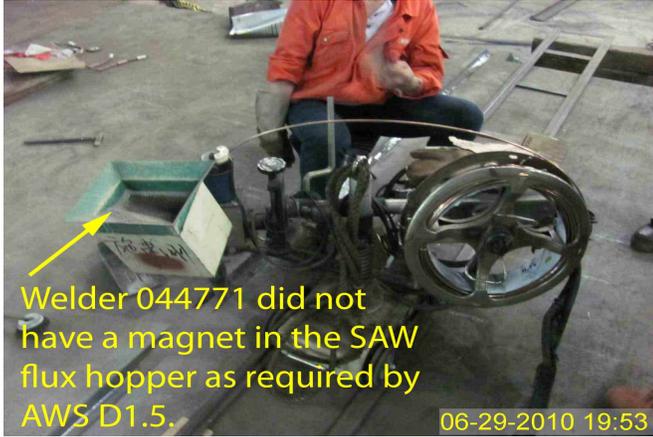
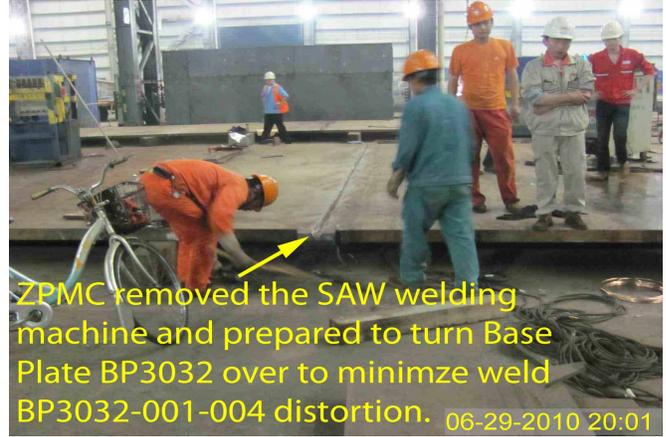
This QA Inspector observed ZPMC welder Ms. Wang Min, stencil 044771 was using submerged arc welding procedure specification WPS-B-T-2221-U3C-S-2 to make OBG segment 13AE bottom plate groove butt weld BP3032-001-004. This QA Inspector observed Ms. Wang Min appears to be certified to make this weld and measured a welding current of approximately 640 amps and 31.0 volts. ZPMC has used electric heating elements to maintain the base material preheat temperature of the steel plates that are being welded. This QA Inspector observed the submerged arc welding machine hopper does not have any magnet as required by AWS D1.5, Paragraph 4.8.4; states: "SAW flux that has not been melted during the welding operation may be reused after recovery by vacuuming, use of catch pans, sweeping from weldment surfaces or other means. Recovered flux shall be passed through an appropriate screen and over a suitable magnet to remove unwanted particles and materials before being returned to the flux supply system." This QA Inspector asked QC Inspector Mr. Guo Xing Hui and ZPMC CWI Mr. Geng Wei why there is no magnet being used and both of the Inspectors informed this QA Inspector that this was the last welding pass that will be made today and after BP3032 is turned over that a magnet will be used when additional submerged arc welding is performed. Items observed on this date do not fully appear to comply with applicable contract documents. See the photographs below for additional information.
