Contract #: 04-0120F4Cty: SF/ALA Rte: 80 PM: 13.2/13.9File #: 99.28**WELDING INSPECTION REPORT****Resident Engineer:** Pursell, Gary**Address:** 333 Burma Road**City:** Oakland, CA 94607**Report No:** WIR-015348**Date Inspected:** 03-Jul-2010**Project Name:** SAS Superstructure**OSM Arrival Time:** 700**Prime Contractor:** American Bridge/Fluor Enterprises, a JV**OSM Departure Time:** 1900**Contractor:** Zhenhua Port Machinery Company, Ltd (ZPMC) Chanxing Island**Location:** Shanghai, China**CWI Name:** Mr. Xu Tao**CWI Present:** Yes No**Inspected CWI report:** Yes No N/A**Rod Oven in Use:** Yes No N/A**Electrode to specification:** Yes No N/A**Weld Procedures Followed:** Yes No N/A**Qualified Welders:** Yes No N/A**Verified Joint Fit-up:** Yes No N/A**Approved Drawings:** Yes No N/A**Approved WPS:** Yes No N/A**Delayed / Cancelled:** Yes No N/A**Bridge No:** 34-0006**Component:** OBG Segment**Summary of Items Observed:**

OBG Segment 11DE

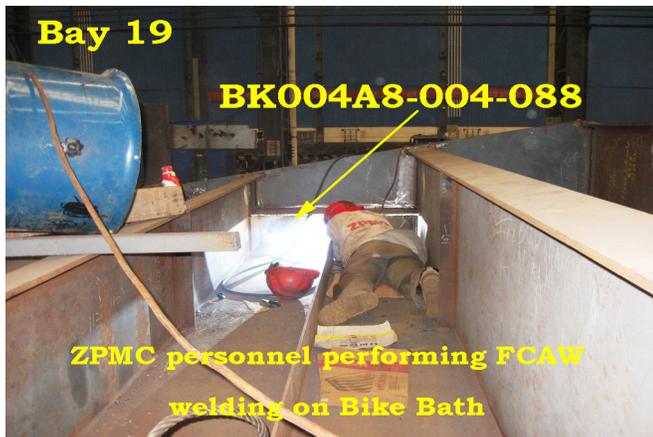
This QA inspector observed ZPMC qualified welding personnel identified as 208641 perform Flux Cored Arc Welding (FCAW) welding on Bike Path, weld joint identified as BK004A8-004-088. ZPMC QC is identified as Mr. Xu Tao. The welding parameters as measured using QC's calibrated instruments appeared to be in general compliance with WPS-B-T-2334-Tc-P4-F. See the attached picture
