DEPARTMENT OF TRANSPORTATION

Contract #: 04-0120F4Cty: SF/ALA Rte: 80 PM: 13.2/13.9File #: 69.28**WELDING INSPECTION REPORT****Resident Engineer:** Pursell, Gary**Address:** 333 Burma Road**City:** Oakland, CA 94607**Report No:** WIR-015527**Date Inspected:** 04-Jul-2010**Project Name:** SAS Superstructure**OSM Arrival Time:** 700**Prime Contractor:** American Bridge/Fluor Enterprises, a JV**OSM Departure Time:** 1900**Contractor:** Zhenhua Port Machinery Company, Ltd (ZPMC), Changxing Island **Location:** Shanghai, China**CWI Name:** ZPMC and ABF**CWI Present:** Yes No**Inspected CWI report:** Yes No N/A**Rod Oven in Use:** Yes No N/A**Electrode to specification:** Yes No N/A**Weld Procedures Followed:** Yes No N/A**Qualified Welders:** Yes No N/A**Verified Joint Fit-up:** Yes No N/A**Approved Drawings:** Yes No N/A**Approved WPS:** Yes No N/A**Delayed / Cancelled:** Yes No N/A**Bridge No:** 34-0006**Component:** OBG 13 section**Summary of Items Observed:**

WELDING INSPECTION REPORT

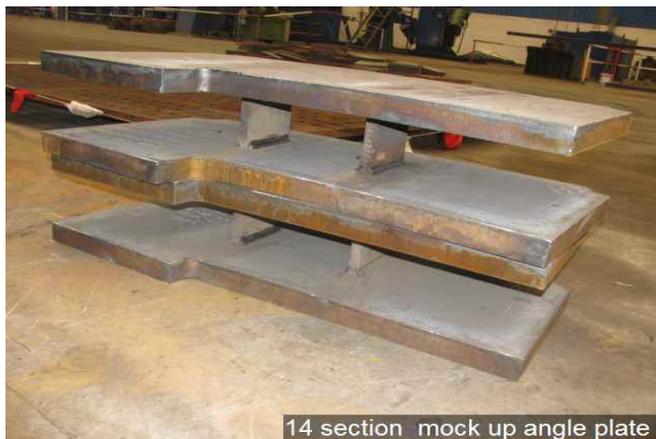
Caltrans QA inspector observed a fit up groups performed fit up and SMAW tack weld process on T-joint stiffeners fillet weld. The T-joint is attached to two angle plates with 45mm wall thick. The angle plate is section #14 mock up. The angle plates have been fit up are SA3348L, SA3748D, SA3354H, SA3349D and SA3355A. A numerous temporary tack welds have been welded attach between angle plate and stiffeners after adjusted and secured by hand jack. The fit up SMAW tack welding process were monitored and recorded by ZPMC and ABF QC inspector. Base on Caltrans QAI observation, no discrepancies were noted.

14 section mock up angle plate

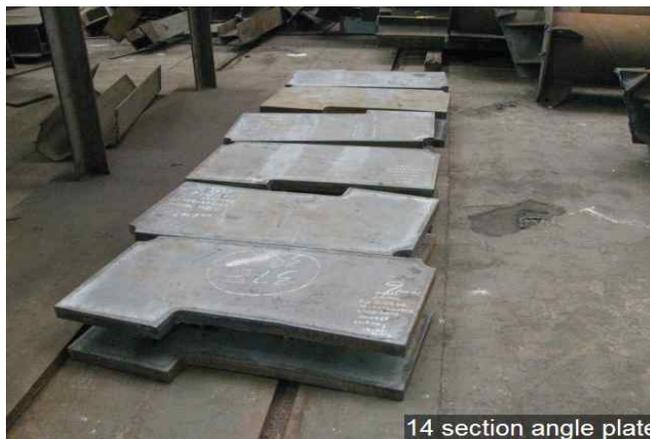
Caltrans QA Inspector observed a welder performed a FCAW process on stiffeners. The stiffener weld is designed 8mm fillet weld with T-joint welded on angle plate. The angle plate is section #14 mock up. The angle plate ID is SA3350B, SA3340G and SA3349A. The FCAW process was monitored and recorded by ZPMC and ABF QC inspector. Based on Caltrans QAI observations, no discrepancies were noted.

14 section angle plate
