**DEPARTMENT OF TRANSPORTATION**

Contract #: 04-0120F4Cty: SF/ALA Rte: 80 PM: 13.2/13.9File #: 69.28**WELDING INSPECTION REPORT****Resident Engineer:** Pursell, Gary**Address:** 333 Burma Road**City:** Oakland, CA 94607**Report No:** WIR-015687**Date Inspected:** 13-Jul-2010**Project Name:** SAS Superstructure**OSM Arrival Time:** 700**Prime Contractor:** American Bridge/Fluor Enterprises, a JV**OSM Departure Time:** 1900**Contractor:** Zhenhua Port Machinery Company, Ltd (ZPMC), Changxing Island **Location:** Shanghai, China**CWI Name:** Mr. Huang min**CWI Present:** Yes No**Inspected CWI report:** Yes No N/A**Rod Oven in Use:** Yes No N/A**Electrode to specification:** Yes No N/A**Weld Procedures Followed:** Yes No N/A**Qualified Welders:** Yes No N/A**Verified Joint Fit-up:** Yes No N/A**Approved Drawings:** Yes No N/A**Approved WPS:** Yes No N/A**Delayed / Cancelled:** Yes No N/A**Bridge No:** 34-0006**Component:** Orthotropic Box Girder (OBG)**Summary of Items Observed:**

## WELDING INSPECTION REPORT

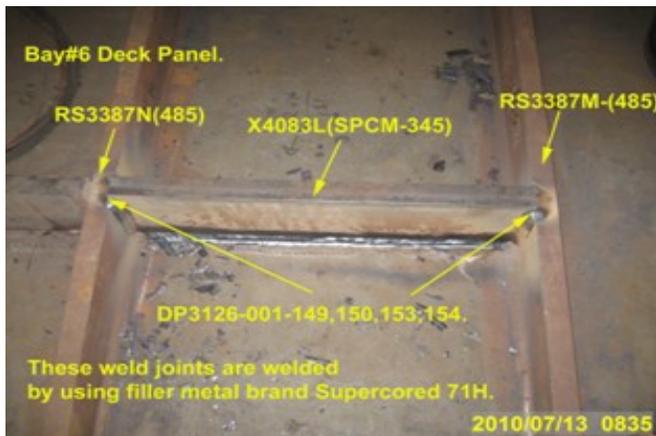
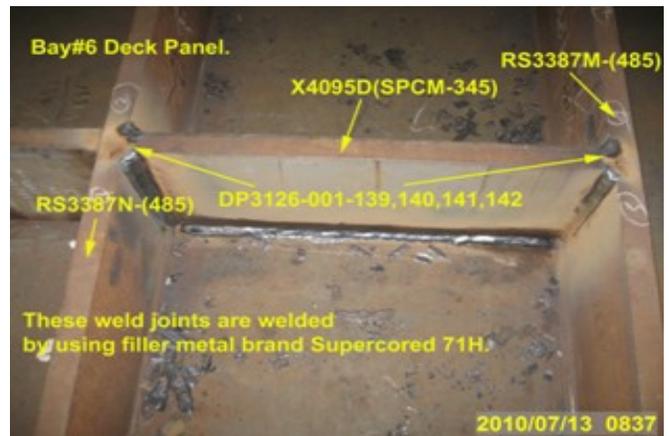
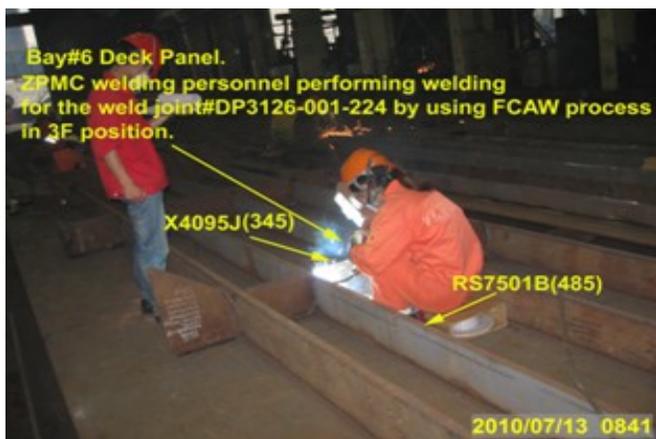
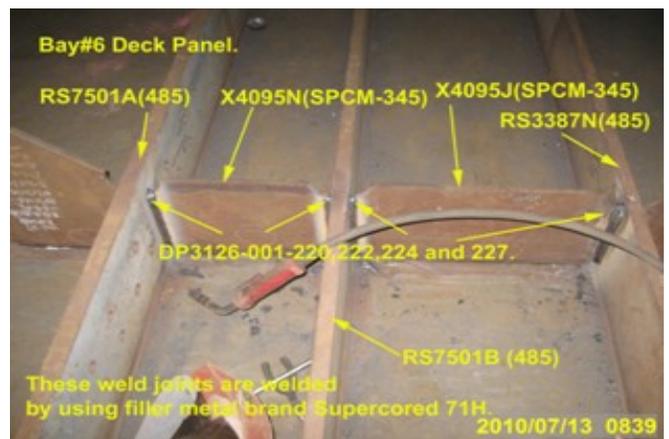
During a random in process inspection of OBG Deck Panel (DP) DP3126A, this Caltrans Quality Assurance (QA) Inspector observed ZPMC welding personnel performing Flux Cored Arc Welding (FCAW) using a WPS that is not approved for the joint being welded. The welding was being performed to WPS-B-T-2133 which specifies A709-345 to A709-345 material using filler metal brand Supercored 71H Class E71T1. The material being welded was A709-345 to A709-HPS-485. The welds are fillet weld T-joints, joining Seismic Performance Critical Material

(SPCM) diaphragms identified as X4095N and X4095J to Rib Stiffeners identified as RS7501A/B and RS3387N/M. Other joints not specified as SPCM include diaphragms identified as X4095D and X4083L welded to the same rib stiffeners. The weld joints are identified as DP3126-001-139~142,149,150,153,154,220,222,224 and 227.

This QA Inspector generated an incident report for the above issue, for further information please see the incident report and attached photos.
