Contract #: 04-0120F4Cty: SF/ALA Rte: 80 PM: 13.2/13.9File #: 69.28**WELDING INSPECTION REPORT****Resident Engineer:** Pursell, Gary**Address:** 333 Burma Road**City:** Oakland, CA 94607**Report No:** WIR-015712**Date Inspected:** 17-Jul-2010**Project Name:** SAS Superstructure**OSM Arrival Time:** 700**Prime Contractor:** American Bridge/Fluor Enterprises, a JV**OSM Departure Time:** 1900**Contractor:** Zhenhua Port Machinery Company, Ltd (ZPMC), Changxing Island **Location:** Shanghai, China**CWI Name:** Li yan hua / Xu tao**CWI Present:** Yes No**Inspected CWI report:** Yes No N/A**Rod Oven in Use:** Yes No N/A**Electrode to specification:** Yes No N/A**Weld Procedures Followed:** Yes No N/A**Qualified Welders:** Yes No N/A**Verified Joint Fit-up:** Yes No N/A**Approved Drawings:** Yes No N/A**Approved WPS:** Yes No N/A**Delayed / Cancelled:** Yes No N/A**Bridge No:** 34-0006**Component:** OBG Components**Summary of Items Observed:**

# WELDING INSPECTION REPORT

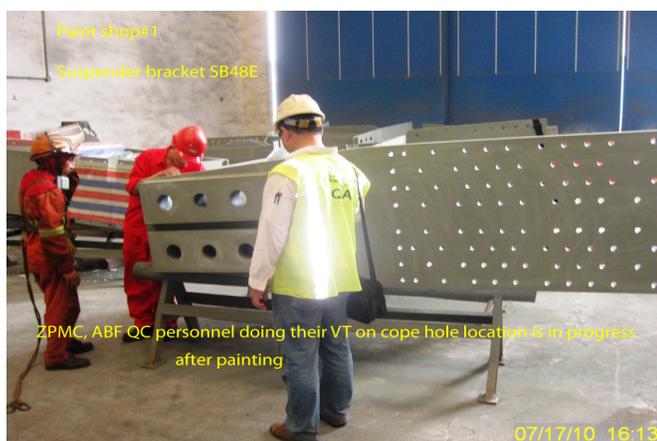
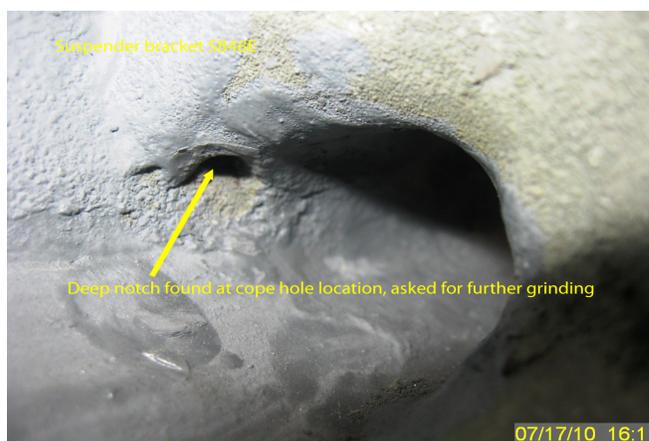
Caltrans Quality Assurance (QA) Inspectors performed random visual inspection of OBG Suspender bracket cope hole locations after Painting.. Areas requiring additional grinding were marked by QA and repaired by ZPMC personnel. The suspender bracket is identified as SB 48E, SB 48W.
