Contract #: 04-0120F4Cty: SF/ALA Rte: 80 PM: 13.2/13.9File #: 69.28**WELDING INSPECTION REPORT****Resident Engineer:** Pursell, Gary**Address:** 333 Burma Road**City:** Oakland, CA 94607**Report No:** WIR-015771**Date Inspected:** 19-Jul-2010**Project Name:** SAS Superstructure**OSM Arrival Time:** 700**Prime Contractor:** American Bridge/Fluor Enterprises, a JV**OSM Departure Time:** 1900**Contractor:** Zhenhua Port Machinery Company, Ltd (ZPMC), Changxing Island **Location:** Shanghai, China**CWI Name:** Mr. Huang min**CWI Present:** Yes No**Inspected CWI report:** Yes No N/A**Rod Oven in Use:** Yes No N/A**Electrode to specification:** Yes No N/A**Weld Procedures Followed:** Yes No N/A**Qualified Welders:** Yes No N/A**Verified Joint Fit-up:** Yes No N/A**Approved Drawings:** Yes No N/A**Approved WPS:** Yes No N/A**Delayed / Cancelled:** Yes No N/A**Bridge No:** 34-0006**Component:** Orthotropic Box Girder (OBG)**Summary of Items Observed:**

WELDING INSPECTION REPORT

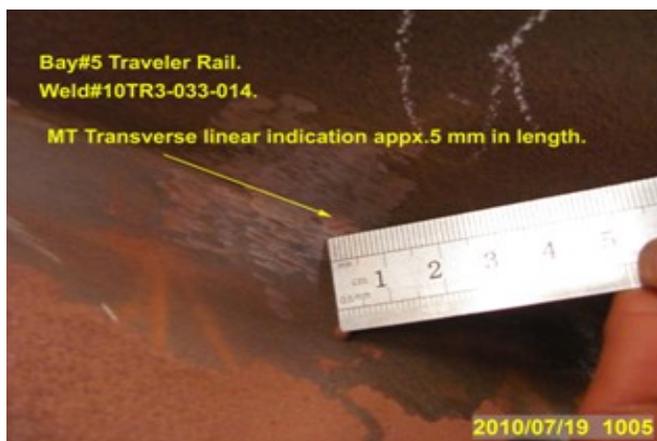
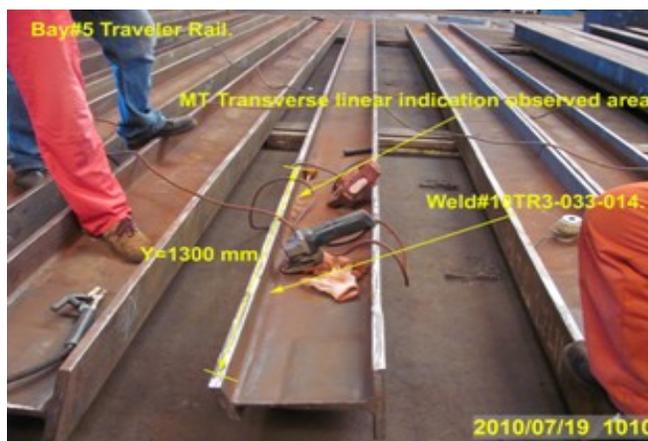
During Quality Assurance Magnetic Particle Testing (MT) review of welds located on Orthotropic Box Girder(OBG) TR 10TR3-033, this QA Inspector observed One (1) Transverse surface Linear indication measuring approximately 5 mm in length. The weld is identified as: 10TR3-033-014. The weld is a Complete Joint Penetration with reinforcement fillet weld joining TR web to flange plate. The "Y" location is approximately 1300 mm from the nearest end of the weld. This indication has been ground out and MT re tested found to be acceptable. The indication is located within the area that has been previously tested and accepted by ZPMC Quality Control (QC) personnel. As per the contract documents, ZPMC QC personnel are required to perform 100% MT inspection of these welds. Refer the attached photos for reference.
