Contract #: 04-0120F4Cty: SF/ALA Rte: 80 PM: 13.2/13.9File #: 69.28**WELDING INSPECTION REPORT****Resident Engineer:** Pursell, Gary**Address:** 333 Burma Road**City:** Oakland, CA 94607**Report No:** WIR-015884**Date Inspected:** 28-Jul-2010**Project Name:** SAS Superstructure**OSM Arrival Time:** 700**Prime Contractor:** American Bridge/Fluor Enterprises, a JV**OSM Departure Time:** 1900**Contractor:** Zhenhua Port Machinery Company, Ltd (ZPMC), Changxing Island **Location:** Shanghai, China

WELDING INSPECTION REPORT

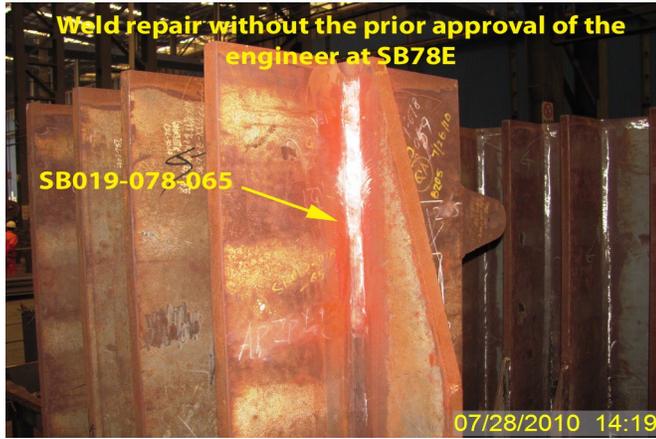
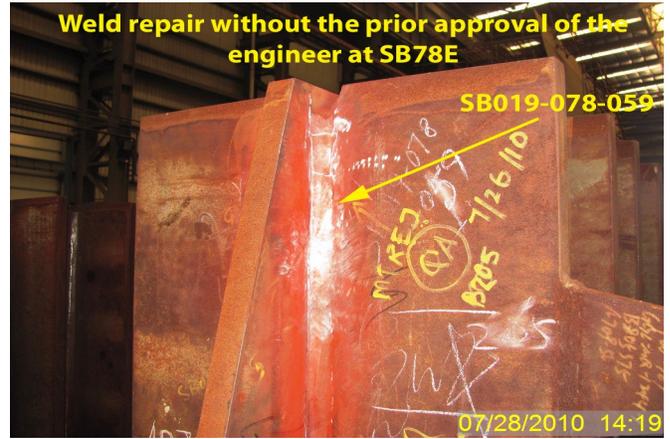
During the Quality Assurance (QA) random in-process visual inspection of Suspender Bracket SB78E, this QA inspector discovered the following issue that the ZPMC performed three (3) weld repairs of Linear Indications without the prior approval of the engineer. The welds are identified as SB019-078-047, SB019-078-059 and SB019-078-065. All welds are designated as Non Seismic Performance Critical Material (Non SPCM). All welds are fillet welds joining between Middle web plate (X56CC) to Stiffeners(X55). OBG Suspender Bracket SB78E is located in Bay#19.

The QA Inspector generated an incident report on this date.
