DEPARTMENT OF TRANSPORTATION

Contract #: 04-0120F4Cty: SF/ALA Rte: 80 PM: 13.2/13.9File #: 69.28**WELDING INSPECTION REPORT****Resident Engineer:** Pursell, Gary**Address:** 333 Burma Road**City:** Oakland, CA 94607**Report No:** WIR-015923**Date Inspected:** 29-Jul-2010**Project Name:** SAS Superstructure**OSM Arrival Time:** 700**Prime Contractor:** American Bridge/Fluor Enterprises, a JV**OSM Departure Time:** 1900**Contractor:** Zhenhua Port Machinery Company, Ltd (ZPMC), Changxing Island **Location:** Shanghai, China**CWI Name:** Li Yang.**CWI Present:** Yes No**Inspected CWI report:** Yes No N/A**Rod Oven in Use:** Yes No N/A**Electrode to specification:** Yes No N/A**Weld Procedures Followed:** Yes No N/A**Qualified Welders:** Yes No N/A**Verified Joint Fit-up:** Yes No N/A**Approved Drawings:** Yes No N/A**Approved WPS:** Yes No N/A**Delayed / Cancelled:** Yes No N/A**Bridge No:** 34-0006**Component:** OBG components.**Summary of Items Observed:**

WELDING INSPECTION REPORT

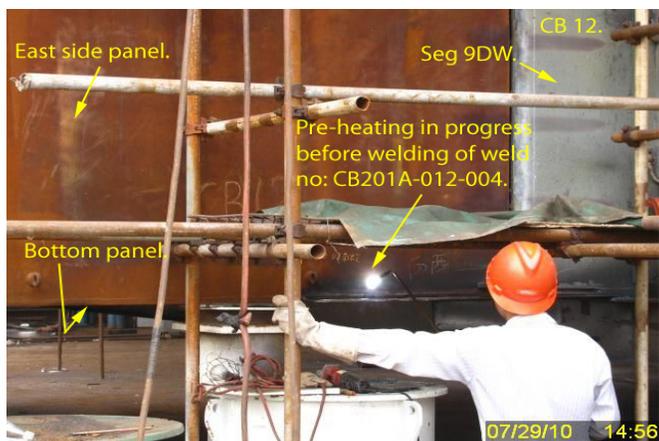
OBG Seg 9BE and Seg 9DE:

Base metal repair welding on FL3 area; after removal of temporary attachments. Welding process was identified as SMAW. The welder was identified as 068091 and was observed welding in the 3G position. ZPMC QC was identified as Li Yang. The welding variables recorded by QC appeared to comply with WPS: 345-SMAW-3G(3F)-FCM-Repair-1. Repair welding was done as per Welding Repair Report (WRR): B-WR-13193 Rev-0. See attached photo for further details.

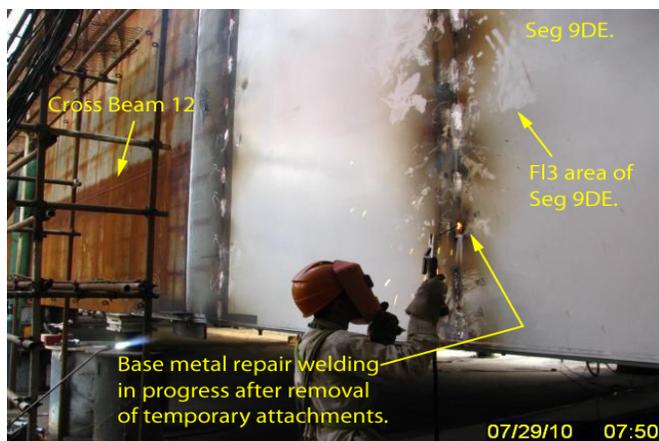
Cross Beam 12 (CB12):

The FCAW process on weld joint no's: CB201A-012-004, 016 and 018. The welders were identified as 222396 and 220066 and were observed welding in the 2G position. ZPMC QC was identified as Li Yang. The welding variables recorded by QC appeared to comply with WPS: B-T-2232-TC-U4b-F-2. See attached photo for further details.
