Contract #: 04-0120F4Cty: SF/ALA Rte: 80 PM: 13.2/13.9File #: 69.28**WELDING INSPECTION REPORT****Resident Engineer:** Pursell, Gary**Address:** 333 Burma Road**City:** Oakland, CA 94607**Report No:** WIR-015949**Date Inspected:** 31-Jul-2010**Project Name:** SAS Superstructure**OSM Arrival Time:** 700**Prime Contractor:** American Bridge/Fluor Enterprises, a JV**OSM Departure Time:** 1900**Contractor:** Zhenhua Port Machinery Company, Ltd (ZPMC), Changxing Island **Location:** Shanghai, China**CWI Name:** Li Yang**CWI Present:** Yes No**Inspected CWI report:** Yes No N/A**Rod Oven in Use:** Yes No N/A**Electrode to specification:** Yes No N/A**Weld Procedures Followed:** Yes No N/A**Qualified Welders:** Yes No N/A**Verified Joint Fit-up:** Yes No N/A**Approved Drawings:** Yes No N/A**Approved WPS:** Yes No N/A**Delayed / Cancelled:** Yes No N/A**Bridge No:** 34-0006**Component:** welder qual**Summary of Items Observed:**

On this date Caltrans OSM Quality Assurance (QA) Inspector, Dan Hernandez was present during the times noted above to observe the fit up, welding and related activities associated with the fabrication of the San Francisco Oakland Bay Self Anchored Suspension Brid

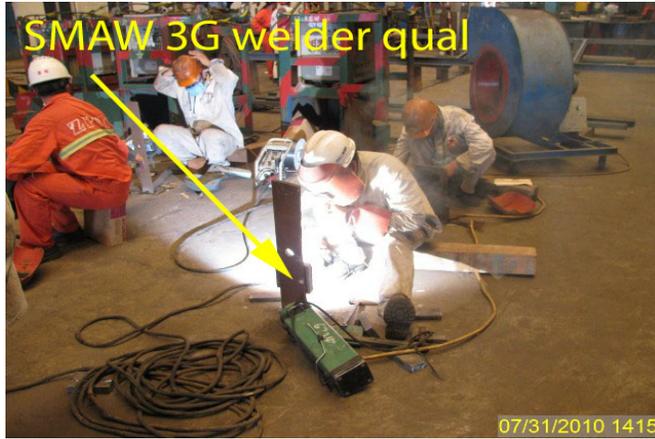
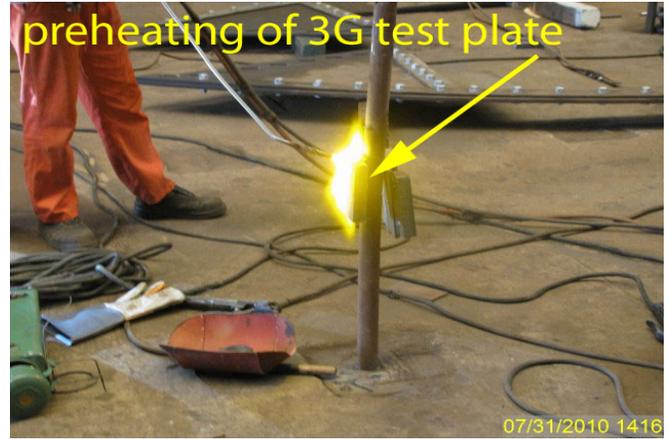
This QA Inspector observed Welder Qualification using the Flux Cored Arc Welding (FCAW) process for Complete Joint Penetration (CJP) Groove Tests for plate of unlimited thickness in the 3G (vertical) position and Fillet Weld Tack Welder Qualification Test in the 4F (overhead) position.

This QA Inspector observed Welder Qualification using the Flux Cored Arc Welding (FCAW) and Shield Metal Arc Welding (SMAW) process for Complete Joint Penetration (CJP) Groove Tests for plate of unlimited thickness in the 3G (vertical) position and SMAW Fillet Weld Tack Welder Qualification Test in the 3F (vertical) position 4F (overhead) position.

Visual for CJP test plates and Tack weld Visual and Fracture Testing results were accepted by ZPMC QC unless otherwise noted.
