Contract #: 04-0120F4Cty: SF/ALA Rte: 80 PM: 13.2/13.9File #: 69.28**WELDING INSPECTION REPORT****Resident Engineer:** Pursell, Gary**Address:** 333 Burma Road**City:** Oakland, CA 94607**Report No:** WIR-016011**Date Inspected:** 29-Jul-2010**Project Name:** SAS Superstructure**OSM Arrival Time:** 700**Prime Contractor:** American Bridge/Fluor Enterprises, a JV**OSM Departure Time:** 1900**Contractor:** Zhenhua Port Machinery Company, Ltd (ZPMC), Changxing Island **Location:** Shanghai, China**CWI Name:** Mr. Xu Le Feng**CWI Present:** Yes No**Inspected CWI report:** Yes No N/A**Rod Oven in Use:** Yes No N/A**Electrode to specification:** Yes No N/A**Weld Procedures Followed:** Yes No N/A**Qualified Welders:** Yes No N/A**Verified Joint Fit-up:** Yes No N/A**Approved Drawings:** Yes No N/A**Approved WPS:** Yes No N/A**Delayed / Cancelled:** Yes No N/A**Bridge No:** 34-0006**Component:** Tower and Orthotropic Box Girder (OBG)**Summary of Items Observed:**

WELDING INSPECTION REPORT

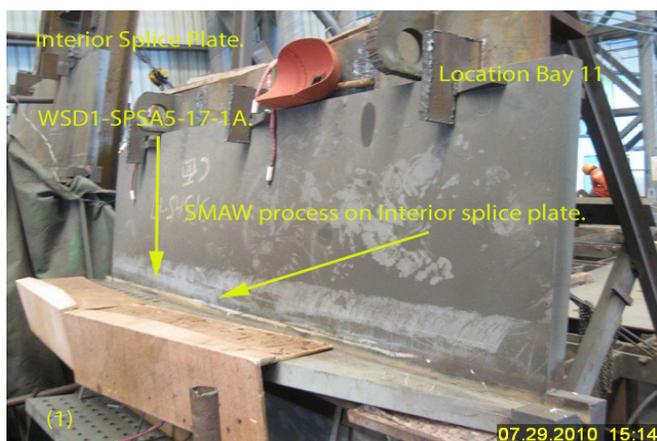
This QA Inspector observed ZPMC qualified welding personnel identified as 054460, Perform Shielded Metal Arc Welding (SMAW) on Interior splice plate. Joint identified as WSD1-SPSA5-17-1A. ZPMC QC Identified as Lijun, The welding parameters as measured using QC's calibrated instrument appeared to be in general compliance with WPS-B-T-3211-Tc-U5b-1. For more information see below attached picture number 1.

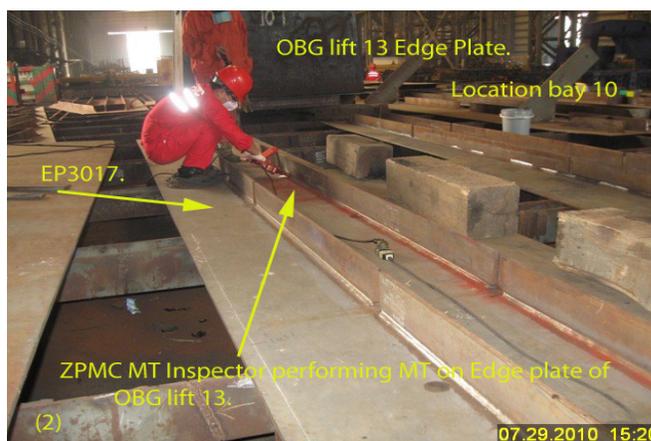
This QA Inspector observed ZPMC Magnetic Particle Testing Inspector, performing MT on Edge Plate of OBG lift 13. Item identified as EP3017. For more information see below attached picture number 2.
