Contract #: 04-0120F4Cty: SF/ALA Rte: 80 PM: 13.2/13.9File #: xx.28**WELDING INSPECTION REPORT****Resident Engineer:** Siegenthaler, Peter**Address:** 333 Burma Road**City:** Oakland, CA 94607**Report No:** WIR-020778**Date Inspected:** 09-Jul-2010**Project Name:** SAS Superstructure**OSM Arrival Time:** 700**Prime Contractor:** American Bridge/Fluor Enterprises, a JV**OSM Departure Time:** 1900**Contractor:** Zhenhua Port Machinery Company, Ltd (ZPMC), Changxing Island **Location:** Shanghai China**CWI Name:** Mr. Huang Min .**CWI Present:** Yes No**Inspected CWI report:** Yes No N/A**Rod Oven in Use:** Yes No N/A**Electrode to specification:** Yes No N/A**Weld Procedures Followed:** Yes No N/A**Qualified Welders:** Yes No N/A**Verified Joint Fit-up:** Yes No N/A**Approved Drawings:** Yes No N/A**Approved WPS:** Yes No N/A**Delayed / Cancelled:** Yes No N/A**Bridge No:** 34-0006**Component:** OBG Subassembly(Bays 5-8)**Summary of Items Observed:**

WELDING INSPECTION REPORT

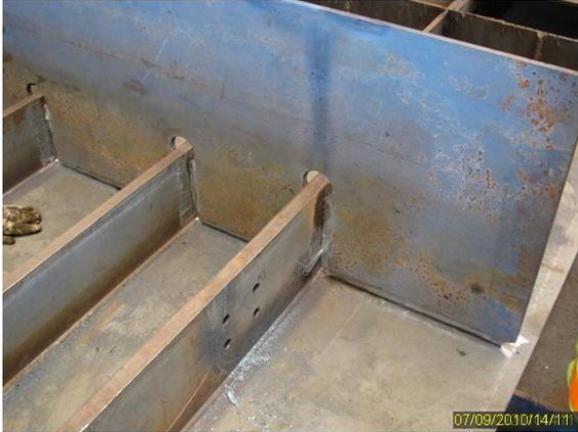
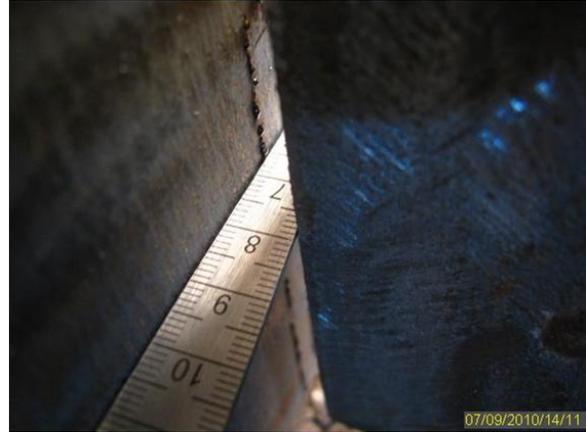
During Surveillance inspection found Fit up for the Weld no.DP3108-001-080/082,Was having 7.5mm Gap and As per drawing that weld is having fillet weld and ZPMC shall change that groove and make CJP. And carry out NDT as CJP Weld, And detail as shown below picture.
