Contract #: 04-0120F4Cty: SF/ALA Rte: 80 PM: 13.2/13.9File #: 69.28**WELDING INSPECTION REPORT****Resident Engineer:** Pursell, Gary**Address:** 333 Burma Road**City:** Oakland, CA 94607**Report No:** WIR-016016**Date Inspected:** 04-Aug-2010**Project Name:** SAS Superstructure**OSM Arrival Time:** 700**Prime Contractor:** American Bridge/Fluor Enterprises, a JV**OSM Departure Time:** 1900**Contractor:** Zhenhua Port Machinery Company, Ltd (ZPMC), Changxing Island **Location:** Shanghai, China**CWI Name:** Mr. Xu Le Feng**CWI Present:** Yes No**Inspected CWI report:** Yes No N/A**Rod Oven in Use:** Yes No N/A**Electrode to specification:** Yes No N/A**Weld Procedures Followed:** Yes No N/A**Qualified Welders:** Yes No N/A**Verified Joint Fit-up:** Yes No N/A**Approved Drawings:** Yes No N/A**Approved WPS:** Yes No N/A**Delayed / Cancelled:** Yes No N/A**Bridge No:** 34-0006**Component:** Tower and Orthotropic Box Girder (OBG)**Summary of Items Observed:**

WELDING INSPECTION REPORT

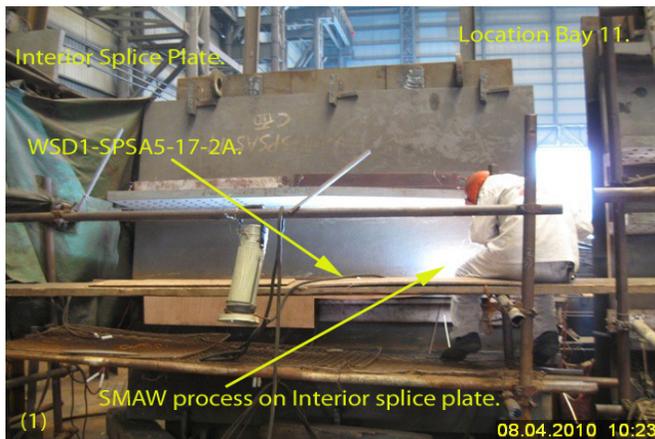
This QA Inspector observed ZPMC qualified welding personnel identified as 054460, Perform Shielded Metal Arc Welding (SMAW) on Interior splice plate. Joint identified as WSD1-SPSA5-17-2A. ZPMC QC Identified as Shao Hai Long, The welding parameters as measured using QC's calibrated instrument appeared to be in general compliance with WPS-B-T-3211-Tc-U5b-1. For more information see below attached picture number 1.

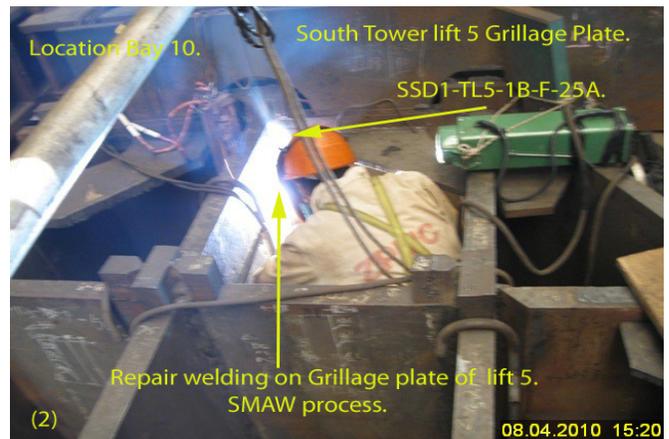
This QA Inspector observed ZPMC qualified welding personnel identified as 056200, Perform Shielded Metal Arc Welding (SMAW) on South Tower lift 5 Grillage plate. Joint identified as SSD1-TL5-1B/F-25A. ZPMC QC Identified as Li Peng Fei with temporary welding repair report. The welding parameters as measured using QC's calibrated instrument appeared to be in general compliance with WPS-485-SMAW-3G (3F) Repair. For more information see below attached picture number 2.
