Quality Assurance and Source Inspection

Contract #: 04-0120F4Cty: SF/ALA Rte: 80 PM: 13.2/13.9File #: 69.28**WELDING INSPECTION REPORT****Resident Engineer:** Pursell, Gary**Address:** 333 Burma Road**City:** Oakland, CA 94607**Report No:** WIR-016132**Date Inspected:** 11-Aug-2010**Project Name:** SAS Superstructure**OSM Arrival Time:** 700**Prime Contractor:** American Bridge/Fluor Enterprises, a JV**OSM Departure Time:** 1900**Contractor:** Zhenhua Port Machinery Company, Ltd (ZPMC), Changxing Island **Location:** Shanghai, China**CWI Name:** Li Yang**CWI Present:** Yes No**Inspected CWI report:** Yes No N/A**Rod Oven in Use:** Yes No N/A**Electrode to specification:** Yes No N/A**Weld Procedures Followed:** Yes No N/A**Qualified Welders:** Yes No N/A**Verified Joint Fit-up:** Yes No N/A**Approved Drawings:** Yes No N/A**Approved WPS:** Yes No N/A**Delayed / Cancelled:** Yes No N/A**Bridge No:** 34-0006**Component:** Welder Qual**Summary of Items Observed:**

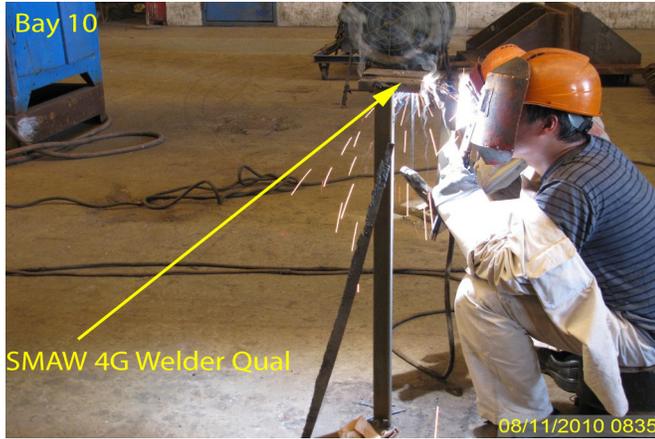
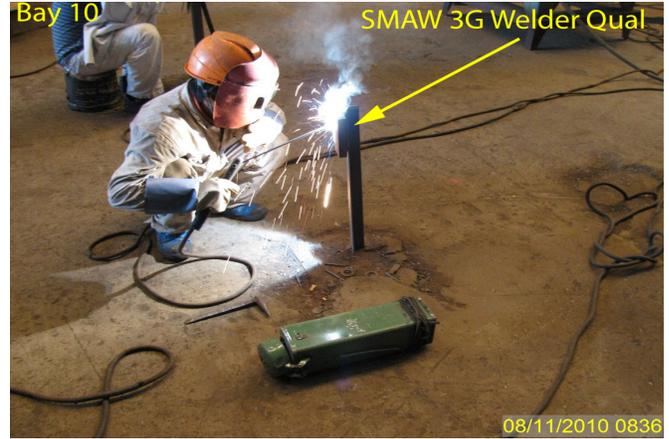
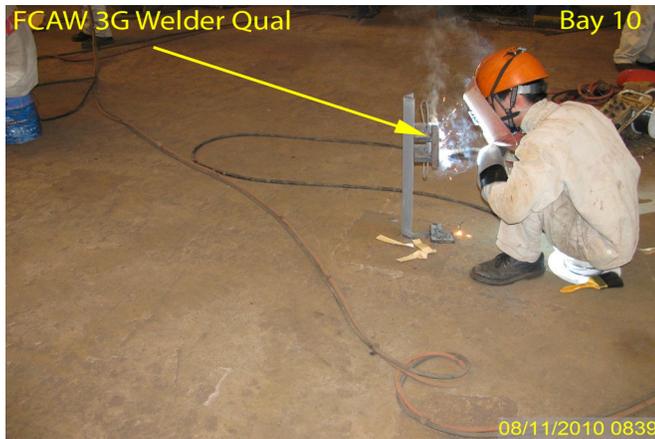
This QA Inspector observed Welder Qualification using the Flux Cored Arc Welding (FCAW) process and Shield Metal Arc Welding (SMAW) process for Groove Weld Qualification (Complete Joint Penetration) for plate of unlimited thickness in the 3G (vertical) and 4G (overhead) position.

ZPMC QC CWI Li Yang was present during Welder qualification. Test coupons will be sent to ZPMC weld lab for Radiographic Testing and Mechanical Bend Tests.

Visual Inspection for CJP test plates were accepted by ZPMC QC unless otherwise noted.
