DEPARTMENT OF TRANSPORTATION

Quality Assurance and Source Inspection

Contract #: 04-0120F4Cty: SF/ALA Rte: 80 PM: 13.2/13.9File #: 99.28**WELDING INSPECTION REPORT****Resident Engineer:** Pursell, Gary**Address:** 333 Burma Road**City:** Oakland, CA 94607**Report No:** WIR-016196**Date Inspected:** 05-Aug-2010**Project Name:** SAS Superstructure**OSM Arrival Time:** 700**Prime Contractor:** American Bridge/Fluor Enterprises, a JV**OSM Departure Time:** 1900**Contractor:** Zhenhua Port Machinery Company, Ltd (ZPMC) Chanxing Island**Location:** Shanghai, China**CWI Name:** Mr. Geng Wei**CWI Present:** Yes No**Inspected CWI report:** Yes No N/A**Rod Oven in Use:** Yes No N/A**Electrode to specification:** Yes No N/A**Weld Procedures Followed:** Yes No N/A**Qualified Welders:** Yes No N/A**Verified Joint Fit-up:** Yes No N/A**Approved Drawings:** Yes No N/A**Approved WPS:** Yes No N/A**Delayed / Cancelled:** Yes No N/A**Bridge No:** 34-0006**Component:** OBG Segments**Summary of Items Observed:**

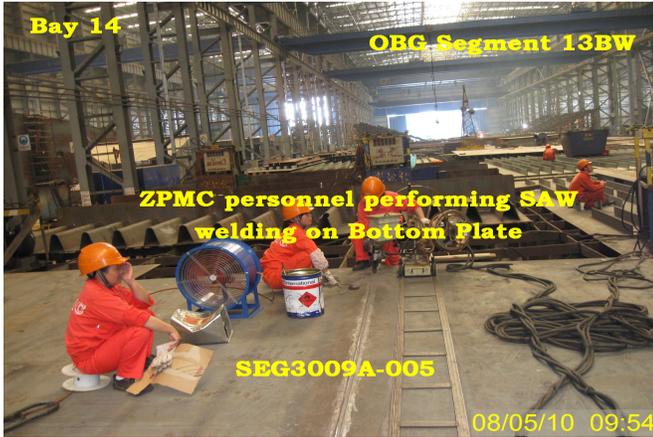
This QA inspector observed ZPMC qualified welding personnel identified as 045270 perform Submerged Arc Welding (SAW) Welding on OBG Segment 13BW, weld joint identified as SEG3014A-004. ZPMC QC is identified as Mr. Wang Xu. The welding parameters as measured using QC's calibrated instruments appeared to be in general compliance with WPS-B-T-2221-B-L2c-S-2. See the attached picture.
