DEPARTMENT OF TRANSPORTATION

Contract #: 04-0120F4Cty: SF/ALA Rte: 80 PM: 13.2/13.9File #: 99.28**WELDING INSPECTION REPORT****Resident Engineer:** Pursell, Gary**Address:** 333 Burma Road**City:** Oakland, CA 94607**Report No:** WIR-016457**Date Inspected:** 27-Aug-2010**Project Name:** SAS Superstructure**OSM Arrival Time:** 700**Prime Contractor:** American Bridge/Fluor Enterprises, a JV**OSM Departure Time:** 1900**Contractor:** Zhenhua Port Machinery Company, Ltd (ZPMC)**Location:** Shanghai, China

Orthotropic Box Girder (OBG) at Trial Assembly Areas

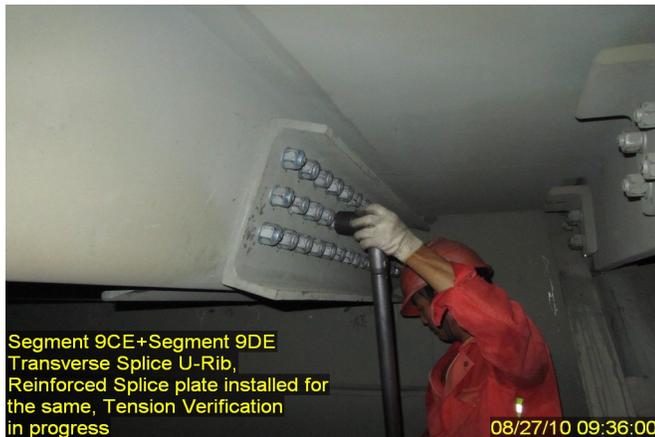
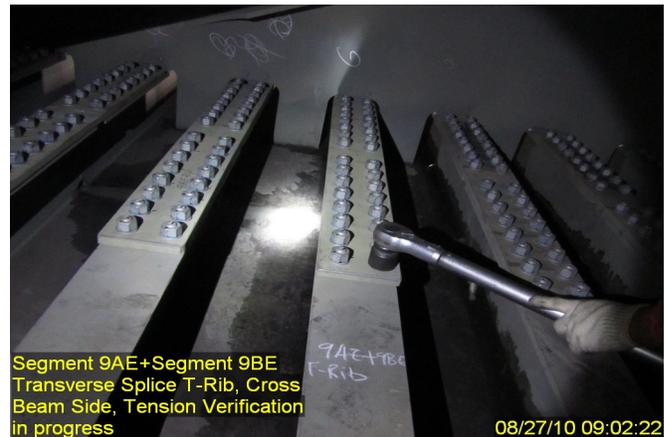
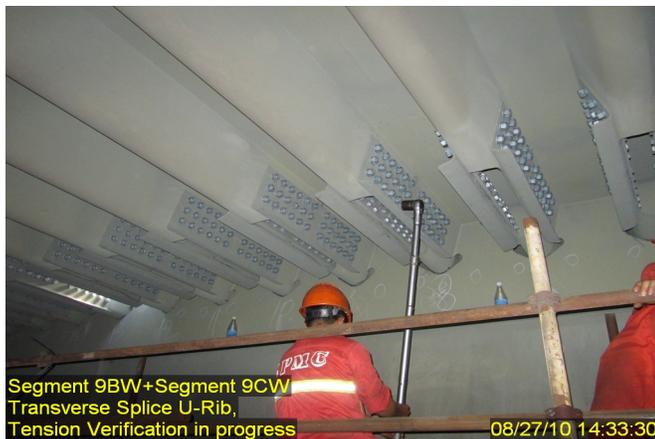
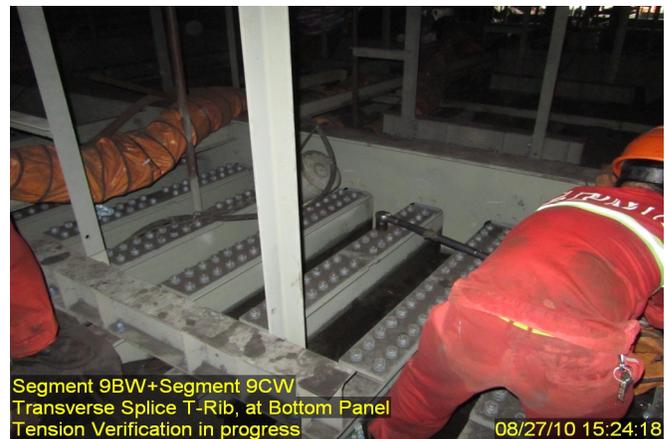
This QA Inspector witnessed final bolt tension verification on bolts connecting T-Rib to T-Rib for Transverse Splice at Side Panel Bike Path Side work point E1 towards work point E3 total 5 T-Ribs, identified as 3rd T-Rib, 4th T-Rib, 5th T-Rib, 16th T-Rib and 17th T-Rib and Side Panel Cross Beam side from work point E4 towards work point E6 total 3 T-Ribs, identified as 4th T-Rib, 5th T-Rib and 6th T-Ribs between Panel Points (PP) 73 to PP 74 for Segment 9AE to 9BE. Inspected the bolt tensioning on a random basis and found the tension to be in general compliance. Inspection was performed against the Notification No. 00462 Dated August 27, 2010.

The bolt sizes used were M22 x 65 RC Lot # DHGM220105 and the final torque value established was 380 N-m.

The bolt sizes used were M22 x 70 RC Lot # DHGM220009 and the final torque value established was 447 N-m.

The Manual Torque wrench used was Serial No. XO2-666. Please reference the pictures attached for more

The Manual Torque wrench used was Serial No. XO2-666. Please reference the pictures attached for more comprehensive details.

The Manual Torque wrench used was Serial No. XO2-779. Please reference the pictures attached for more comprehensive details.
