**DEPARTMENT OF TRANSPORTATION**

OBG SEGMENT 9DW-9EW

# WELDING INSPECTION REPORT

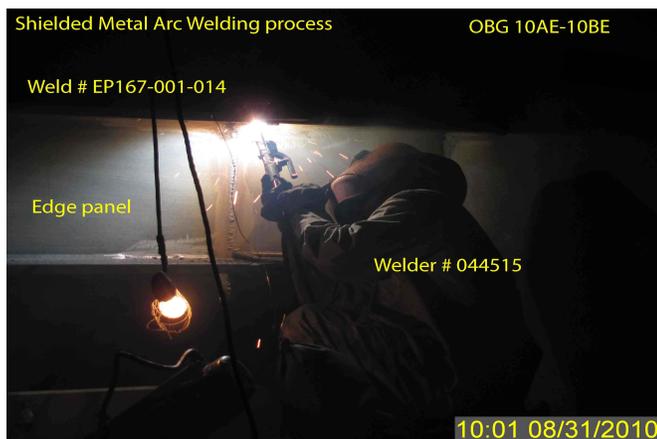
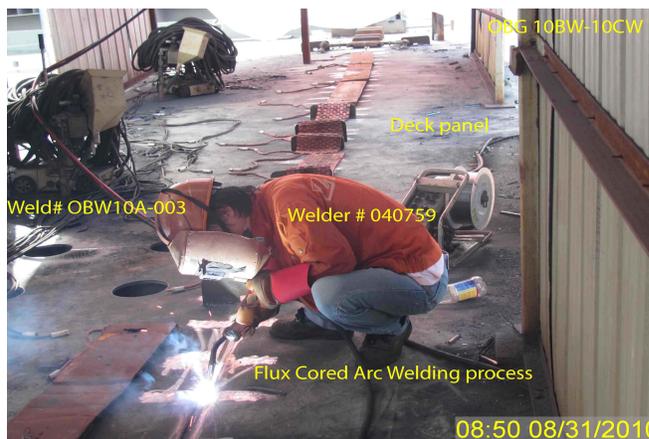
This Quality Assurance (QA) Inspector observed ZPMC qualified welder 040759 performing the Flux Cored Arc Welding process on weld 003 located at PCMK OBW10A. ZPMC QC Mr. Zhong Peng was monitoring this welding operation. The welding variables recorded by QC appeared to comply with WPS-B-T-223 (2) 1T-2.

This Quality Assurance (QA) Inspector observed ZPMC qualified welder 046706 performing the Flux Cored Arc Welding process on weld 003 located at PCMK OBW10C. ZPMC QC Mr. Zhong Peng was monitoring this welding operation. The welding variables recorded by QC appeared to comply with WPS-B-T-223 (2) 1T-2.

This Quality Assurance (QA) Inspector observed ZPMC qualified welder 040367 performing the Flux Cored Arc Welding process on weld 030 located at PCMK BP183-001. ZPMC QC Mr. Wang Li Yang was monitoring this welding operation. The welding variables recorded by QC appeared to comply with WPS-B-T-2233T.

This Quality Assurance (QA) Inspector observed ZPMC qualified welder 044515 performing the Shielded Metal Arc Welding process on weld 014 located at PCMK EP167-001. ZPMC QC Mr. Wang Li Yang was monitoring this welding operation. The welding variables recorded by QC appeared to comply with WPS-B-P-2214-B-u4-fcm-1.

This Quality Assurance (QA) Inspector observed ZPMC qualified welder 040504 performing the Shielded Metal Arc Welding process on weld 044 located at PCMK SP350-001. ZPMC QC Mr. Wang Li Yang was monitoring this welding operation. The welding variables recorded by QC appeared to comply with WPS-B-P-2214-B-u2-fcm-1.

This Quality Assurance (QA) Inspector observed ZPMC qualified welder 044473 performing the Flux Cored Arc Welding process on weld 005 located at PCMK SP324-001. ZPMC QC Mr. Wang Li Yang was monitoring this welding operation. The welding variables recorded by QC appeared to comply with WPS-B-T-2132.

Unless otherwise noted, all work observed on this date appeared to generally comply with applicable contract documents.
