**DEPARTMENT OF TRANSPORTATION**

Contract #: 04-0120F4Cty: SF/ALA Rte: 80 PM: 13.2/13.9File #: 69.28**WELDING INSPECTION REPORT****Resident Engineer:** Siegenthaler, Peter**Address:** 333 Burma Road**City:** Oakland, CA 94607**Report No:** WIR-017111**Date Inspected:** 11-Sep-2010**Project Name:** SAS Superstructure**OSM Arrival Time:** 700**Prime Contractor:** American Bridge/Fluor Enterprises, a JV**OSM Departure Time:** 1900**Contractor:** Zhenhua Port Machinery Company, Ltd (ZPMC), Changxing Island **Location:** Shanghai, China**CWI Name:** Xu Tao**CWI Present:** Yes No**Inspected CWI report:** Yes No N/A**Rod Oven in Use:** Yes No N/A**Electrode to specification:** Yes No N/A**Weld Procedures Followed:** Yes No N/A**Qualified Welders:** Yes No N/A**Verified Joint Fit-up:** Yes No N/A**Approved Drawings:** Yes No N/A**Approved WPS:** Yes No N/A**Delayed / Cancelled:** Yes No N/A**Bridge No:** 34-0006**Component:** OBG COMPONENT**Summary of Items Observed:**

# WELDING INSPECTION REPORT

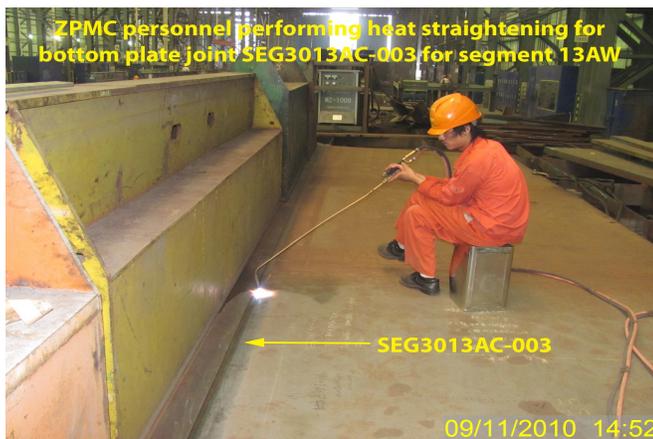
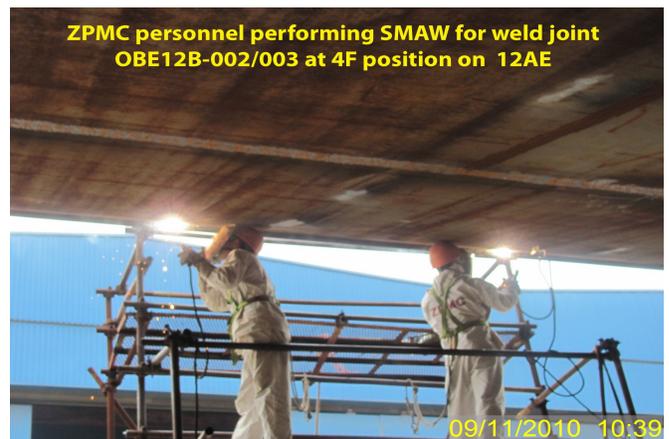
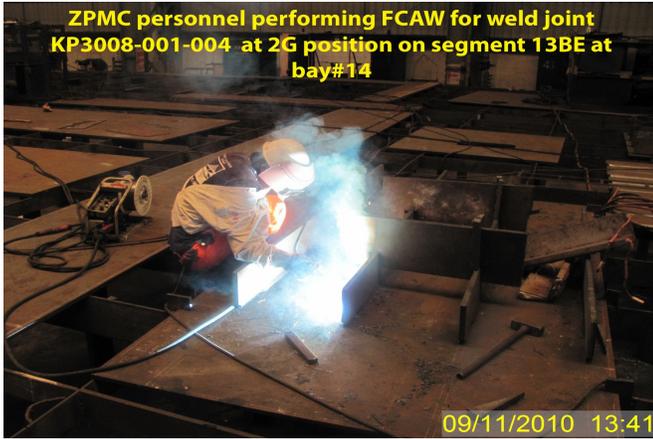
SMAW in the 4F position for the OBG segment 12AE, weld No. OBE12B-002/003. The welders are identified as #044772 and #044779. ZPMC QC is identified as Mr. Li Ping. The welding variables recorded by QC appear to comply with WPS-B-P-2114-FCM-1.

SAW in the 1G position for the OBG segment 13AE, weld No. BP3050-001-002. The welder is identified as #219168. ZPMC QC is identified as Mr. Li Ming Yang. The welding variables recorded by QC appear to comply with WPS-B-T-2221-B-L2c-S-2.

FCAW in the 2G position for the OBG segment 13BE, weld No. KP3008-001-004. The welder is identified as #067079. ZPMC QC is identified as Mr. Wang Xu. The welding variables recorded by QC appear to comply with WPS-B-T-2232-Tc-U4b-F.

This Quality Assurance (QA) Inspector performed random visual inspection of OBG segment 11BW internal Floor beam and deck panel surfaces after grit blasting in between panel point PP98 to PP100. Areas that marked for repair were recorded for future repair. Areas requiring additional grinding were marked by QA and repaired by ZPMC personnel.

This QA Inspector performed Ultrasonic testing (UT) 10% of the area previously tested and accepted by ZPMC Quality control personnel. This QA inspector generated a (UT) report for this date. The member is identified as splice joint joining between side plate to side Plate for segment 10AW to 10BW at counter weight side. This Inspection was performed after ABF UT Inspectors performed UT of this joint. The result was recorded onto a data sheet according to rejection criteria of "D" Scan procedure that Caltrans QA and ABF QA have jointly filled out on this date. The QA inspector found no rejectable indication at scanned area.
