DEPARTMENT OF TRANSPORTATION

Contract #: 04-0120F4Cty: SF/ALA Rte: 80 PM: 13.2/13.9File #: 69.28**WELDING INSPECTION REPORT****Resident Engineer:** Siegenthaler, Peter**Address:** 333 Burma Road**City:** Oakland, CA 94607**Report No:** WIR-017164**Date Inspected:** 28-Sep-2010**Project Name:** SAS Superstructure**OSM Arrival Time:** 700**Prime Contractor:** American Bridge/Fluor Enterprises, a JV**OSM Departure Time:** 1900**Contractor:** Zhenhua Port Machinery Company, Ltd (ZPMC), Changxing Island **Location:** Shanghai, China**CWI Name:** Mr. Xu Tao/Lv Li Qing**CWI Present:** Yes No**Inspected CWI report:** Yes No N/A**Rod Oven in Use:** Yes No N/A**Electrode to specification:** Yes No N/A**Weld Procedures Followed:** Yes No N/A**Qualified Welders:** Yes No N/A**Verified Joint Fit-up:** Yes No N/A**Approved Drawings:** Yes No N/A**Approved WPS:** Yes No N/A**Delayed / Cancelled:** Yes No N/A**Bridge No:** 34-0006**Component:** OBG**Summary of Items Observed:**

WELDING INSPECTION REPORT

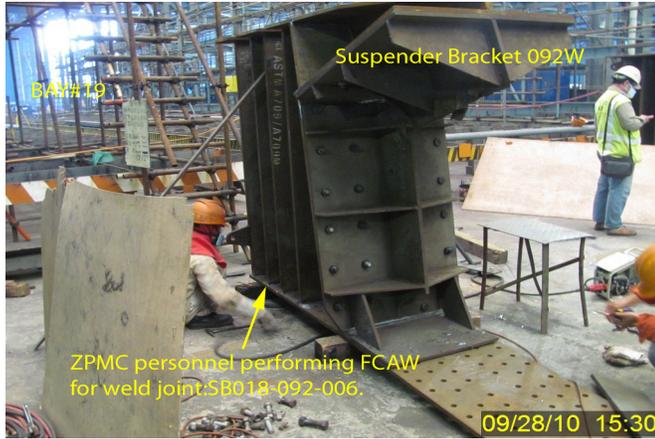
FCAW in the 2F position for the Suspender Bracket (SB 092W), weld No: SB018-092-006. The welder is identified as #062755. ABF QA is identified as Mr. Peng Wei Jun. The welding variables recorded by QC appear

to comply with WPS-B-T-2132. Please see the attached picture.

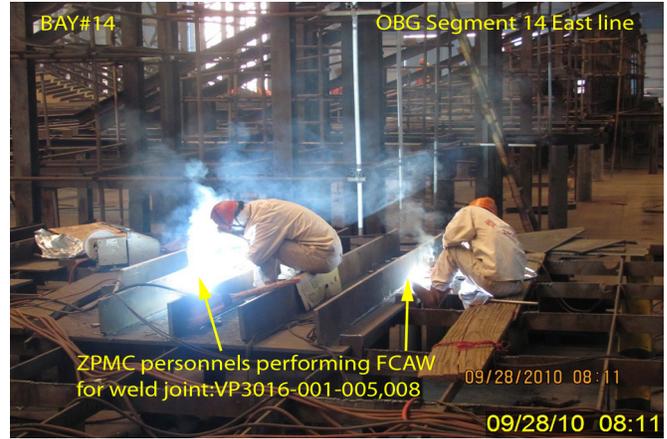
FCAW in the 2G position for the OBG Segment 14 East line, weld No: VP3016-001-005,008. The welders are identified as #066763, 069089. ZPMC CWI is identified as Mr. Lv Li Qing. The welding variables recorded by QC appear to comply with WPS-B-T-2232-TC-U4B-F. Please see the attached picture.
