Contract #: 04-0120F4Cty: SF/ALA Rte: 80 PM: 13.2/13.9File #: 69.28**WELDING INSPECTION REPORT****Resident Engineer:** Siegenthaler, Peter**Address:** 333 Burma Road**City:** Oakland, CA 94607**Report No:** WIR-017394**Date Inspected:** 16-Sep-2010**Project Name:** SAS Superstructure**OSM Arrival Time:** 700**Prime Contractor:** American Bridge/Fluor Enterprises, a JV**OSM Departure Time:** 1900**Contractor:** Zhenhua Port Machinery Company, Ltd (ZPMC), Changxing Island **Location:** Shanghai, China

Bridge No: 34-0006**Component:** Tower**Summary of Items Observed:**

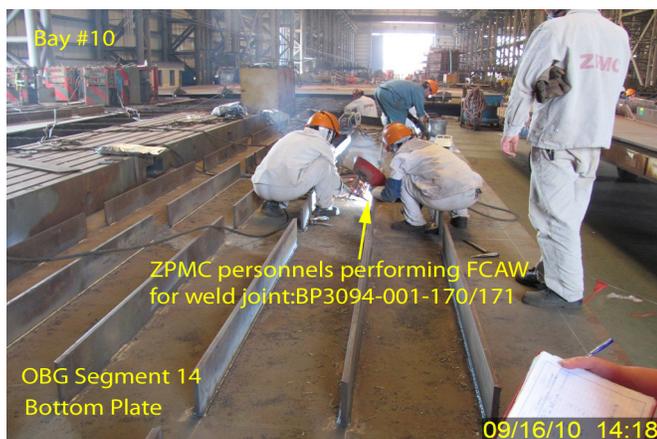
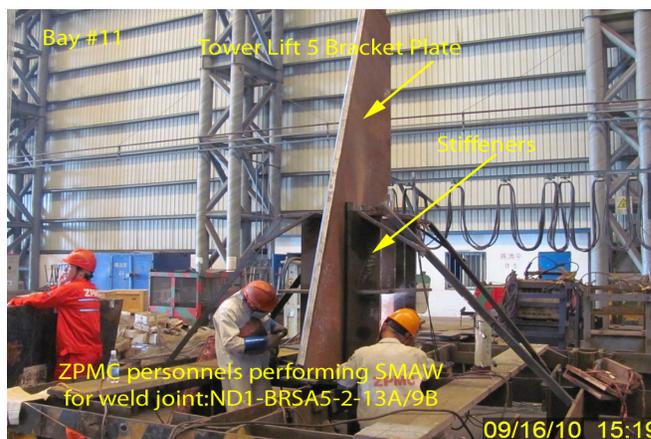
SMAW in the 3G position for the Tower Lift 5 Bracket Plate to Stiffener, weld No: ND1-BRSA5-2-13A. The welder is identified as #054469. ZPMC QC is identified as Mr. Zhao mao mao. The welding variables recorded by QC appear to comply with WPS-B-T-3213-TC-U4b. Please see the attached pictures.

SMAW in the 3G position for the Tower Lift 5 Bracket Plate to Stiffener, weld No: ND1-BRSA5-2-9B. The welder is identified as #044541. ZPMC QC is identified as Mr. Zhao mao mao. The welding variables recorded by QC appear to comply with WPS-B-T-3213-TC-U4b. Please see the attached pictures.
