**DEPARTMENT OF TRANSPORTATION**

Quality Assurance and Source Inspection

Contract #: 04-0120F4Cty: SF/ALA Rte: 80 PM: 13.2/13.9File #: 69.28**WELDING INSPECTION REPORT****Resident Engineer:** Siegenthaler, Peter**Address:** 333 Burma Road**City:** Oakland, CA 94607**Report No:** WIR-017381**Date Inspected:** 05-Oct-2010**Project Name:** SAS Superstructure**OSM Arrival Time:** 700**Prime Contractor:** American Bridge/Fluor Enterprises, a JV**OSM Departure Time:** 1900**Contractor:** Zhenhua Port Machinery Company, Ltd (ZPMC), Changxing Island **Location:** Shanghai, China**CWI Name:** Xu tao**CWI Present:** Yes No**Inspected CWI report:** Yes No N/A**Rod Oven in Use:** Yes No N/A**Electrode to specification:** Yes No N/A**Weld Procedures Followed:** Yes No N/A**Qualified Welders:** Yes No N/A**Verified Joint Fit-up:** Yes No N/A**Approved Drawings:** Yes No N/A**Approved WPS:** Yes No N/A**Delayed / Cancelled:** Yes No N/A**Bridge No:** 34-0006**Component:** OBG Components**Summary of Items Observed:**

## WELDING INSPECTION REPORT

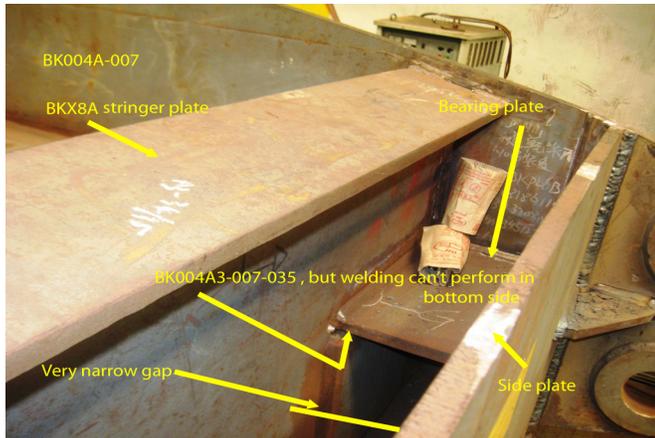
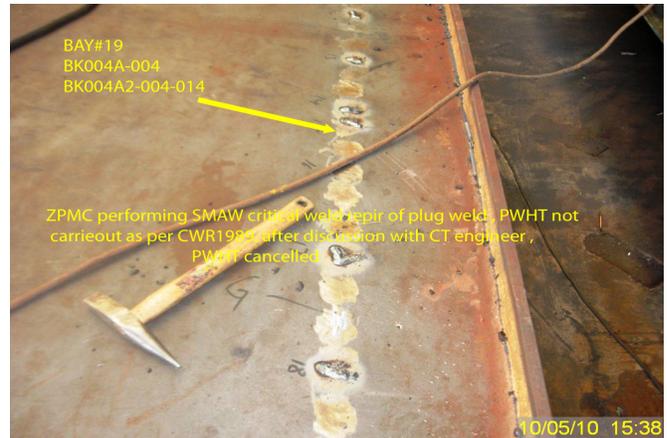
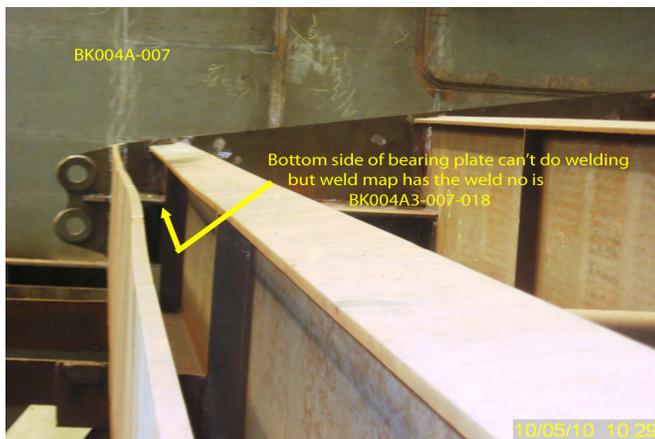
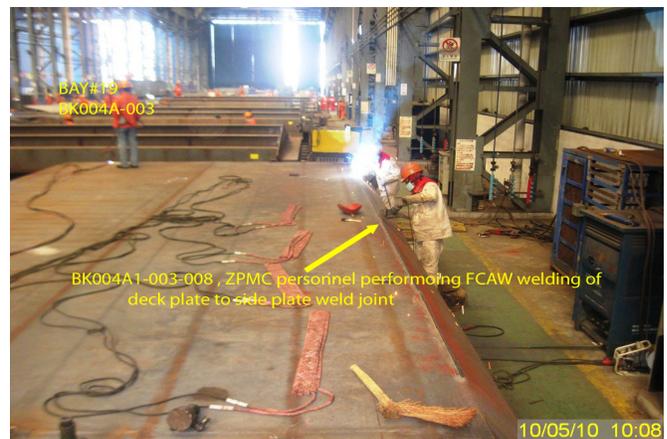
During in process visual inspection it is observed that ZPMC cannot perform welding of fillet Weld in following location where Bearing plate connects with stringer plate, this is because of No access to perform welding. The bike path is identified as BK004A-007. The weld no is identified as, and this is identical to all bike paths. For more information see attached photos.

BK004A3-007-035.

BK004A3-007-018.
