**DEPARTMENT OF TRANSPORTATION**

Contract #: 04-0120F4Cty: SF/ALA Rte: 80 PM: 13.2/13.9File #: 99.28**WELDING INSPECTION REPORT****Resident Engineer:** Siegenthaler, Peter**Address:** 333 Burma Road**City:** Oakland, CA 94607**Report No:** WIR-017407**Date Inspected:** 07-Oct-2010**Project Name:** SAS Superstructure**OSM Arrival Time:** 700**Prime Contractor:** American Bridge/Fluor Enterprises, a JV**OSM Departure Time:** 1900**Contractor:** Zhenhua Port Machinery Company, Ltd (ZPMC) Chanxing Island **Location:** Shanghai, China**CWI Name:** Mr. Xu Tao**CWI Present:** Yes No**Inspected CWI report:** Yes No N/A**Rod Oven in Use:** Yes No N/A**Electrode to specification:** Yes No N/A**Weld Procedures Followed:** Yes No N/A**Qualified Welders:** Yes No N/A**Verified Joint Fit-up:** Yes No N/A**Approved Drawings:** Yes No N/A**Approved WPS:** Yes No N/A**Delayed / Cancelled:** Yes No N/A**Bridge No:** 34-0006**Component:** OBG Segment & Bike Path**Summary of Items Observed:**

## WELDING INSPECTION REPORT

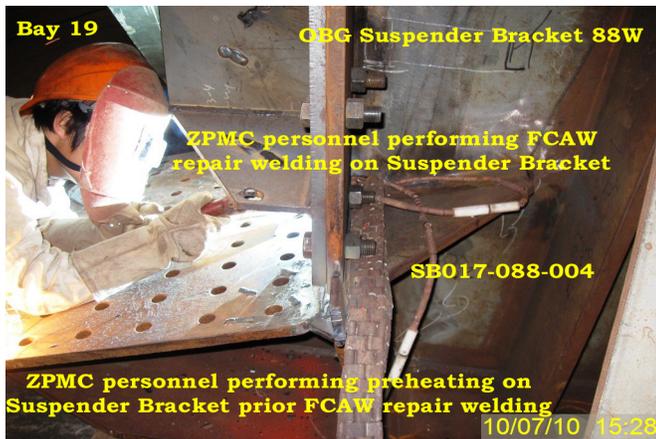
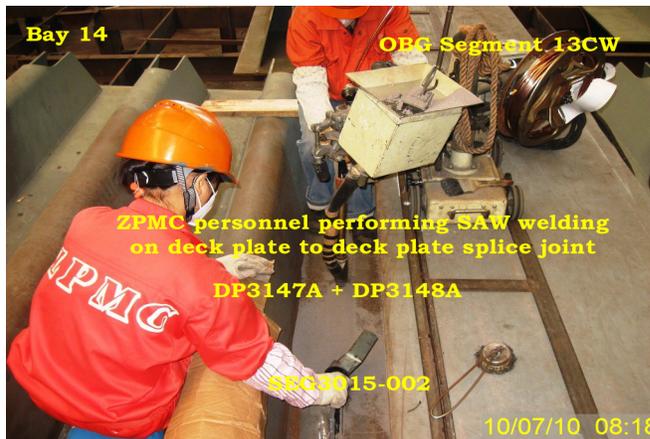
Submerged Arc Welding (SAW) welding of weld joint SEG3015-002 located on the deck plate to deck plate splice joint of OBG Segment 13CW. Welder is identified as 250050. ZPMC Quality Control (QC) is identified as Mis. Lv Yun. The welding variables recorded by QC appeared to comply with the Applicable WPS-B-T-2221-B-L2c-S-2. See the attached photos.
