Quality Assurance and Source Inspection

Contract #: 04-0120F4Cty: SF/ALA Rte: 80 PM: 13.2/13.9File #: 69.28**WELDING INSPECTION REPORT****Resident Engineer:** Siegenthaler, Peter**Address:** 333 Burma Road**City:** Oakland, CA 94607**Report No:** WIR-017465**Date Inspected:** 17-Oct-2010**Project Name:** SAS Superstructure**OSM Arrival Time:** 700**Prime Contractor:** American Bridge/Fluor Enterprises, a JV**OSM Departure Time:** 1900**Contractor:** Zhenhua Port Machinery Company, Ltd (ZPMC), Changxing Island **Location:** Shanghai, China**CWI Name:** Lv Li Qing**CWI Present:** Yes No**Inspected CWI report:** Yes No N/A**Rod Oven in Use:** Yes No N/A**Electrode to specification:** Yes No N/A**Weld Procedures Followed:** Yes No N/A**Qualified Welders:** Yes No N/A**Verified Joint Fit-up:** Yes No N/A**Approved Drawings:** Yes No N/A**Approved WPS:** Yes No N/A**Delayed / Cancelled:** Yes No N/A**Bridge No:** 34-0006**Component:** OBG**Summary of Items Observed:**

OBG SEGMENT 13AE-13BE

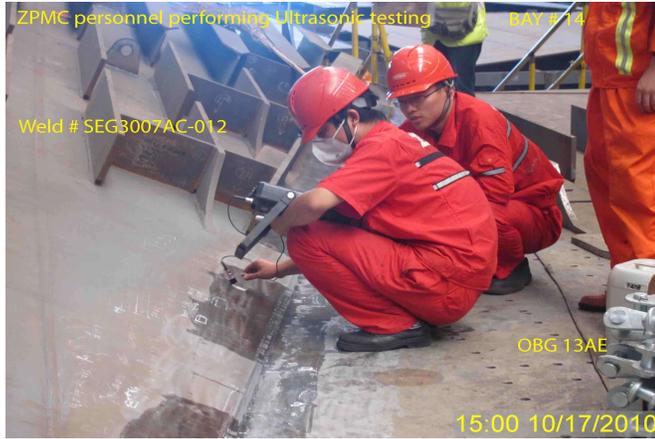
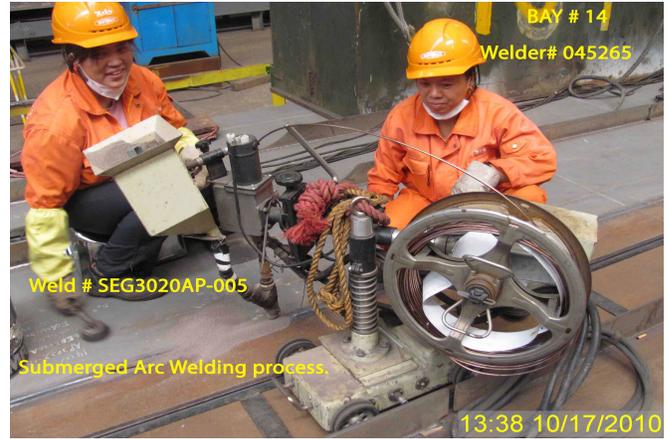
This QA Inspector performed verification Ultrasonic Testing (UT) in accordance with ABF/CT Pattern "D" UT Procedure 001 Revision 1. All recordable Indications if found were recorded on a separate data sheet that Caltrans QA generates after performing a joint inspection with ABF ultrasonic testing personnel. The location of the inspection was identified as the side panel splice weld between OBG segment 13AE and 13BE on cross beam side. The weld designations were as follows:

OBE13C-003 (OBG 13AE-13BE, SP, CB side)

This Quality Assurance (QA) Inspector observed ZPMC qualified welder 066673 performing the Flux Cored Arc Welding process on weld 008 located at PCMK SEG3015A. ZPMC QC Mr. Wang Jie was monitoring this welding operation. The welding variables recorded by QC appeared to comply with WPS-B-T-2131T.
