**DEPARTMENT OF TRANSPORTATION**

Contract #: 04-0120F4Cty: SF/ALA Rte: 80 PM: 13.2/13.9File #: 69.28**WELDING INSPECTION REPORT****Resident Engineer:** Siegenthaler, Peter**Address:** 333 Burma Road**City:** Oakland, CA 94607**Report No:** WIR-017468**Date Inspected:** 18-Oct-2010**Project Name:** SAS Superstructure**OSM Arrival Time:** 700**Prime Contractor:** American Bridge/Fluor Enterprises, a JV**OSM Departure Time:** 1900**Contractor:** Zhenhua Port Machinery Company, Ltd (ZPMC), Changxing Island **Location:** Shanghai, China**CWI Name:** Li Yang**CWI Present:** Yes No**Inspected CWI report:** Yes No N/A**Rod Oven in Use:** Yes No N/A**Electrode to specification:** Yes No N/A**Weld Procedures Followed:** Yes No N/A**Qualified Welders:** Yes No N/A**Verified Joint Fit-up:** Yes No N/A**Approved Drawings:** Yes No N/A**Approved WPS:** Yes No N/A**Delayed / Cancelled:** Yes No N/A**Bridge No:** 34-0006**Component:** OBG Segments**Summary of Items Observed:**

## WELDING INSPECTION REPORT

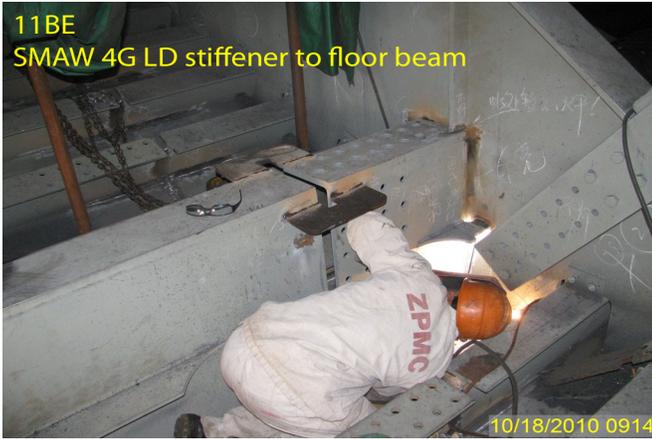
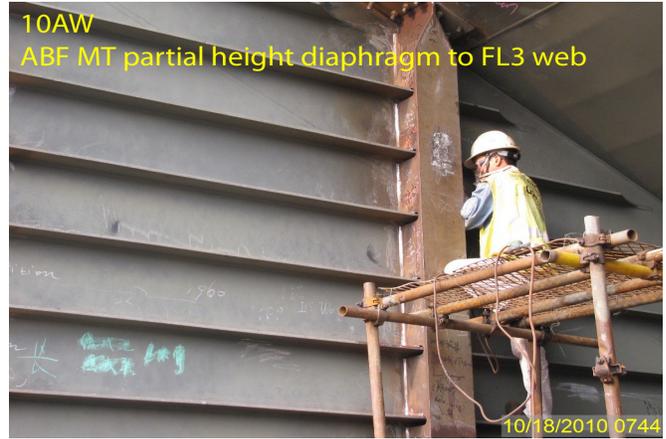
This QA Inspector observed Shielded Metal Arc Welding (SMAW) in progress of a fillet weld joint. The Weld joint is designated as OBE10D-013, 014, Drip Plate. The welder is identified as #056200 and was observed welding in the 4F (overhead) position using approved Welding Procedure Specification WPS-B-P-2114-FCM-1.

This QA Inspector observed Shielded Metal Arc Welding (SMAW) in progress of a fillet weld joint. The Weld joint is designated as OBE10-013, Arc Plate. The welder is identified as #056200 and was observed welding in the 3F (vertical) position using approved Welding Procedure Specification WPS-B-P-2113-FCM-1.

This QA Inspector observed Shielded Metal Arc Welding (SMAW) in progress of a Complete Joint Penetration (CJP) weld joint. The Weld joint is designated as SEG068-057, Longitudinal Diaphragm stiffener to Floor Beam.
