DEPARTMENT OF TRANSPORTATION

Quality Assurance and Source Inspection

Contract #: 04-0120F4Cty: SF/ALA Rte: 80 PM: 13.2/13.9File #: 69.28**WELDING INSPECTION REPORT****Resident Engineer:** Siegenthaler, Peter**Address:** 333 Burma Road**City:** Oakland, CA 94607**Report No:** WIR-017513**Date Inspected:** 05-Oct-2010**Project Name:** SAS Superstructure**OSM Arrival Time:** 700**Prime Contractor:** American Bridge/Fluor Enterprises, a JV**OSM Departure Time:** 1900**Contractor:** Zhenhua Port Machinery Company, Ltd (ZPMC), Changxing Island **Location:** Shanghai, China

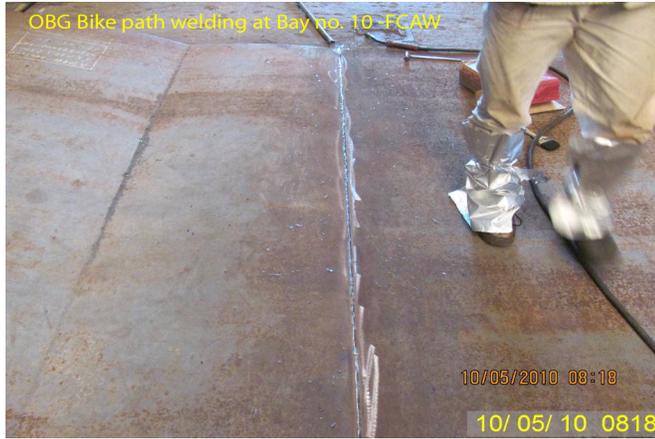
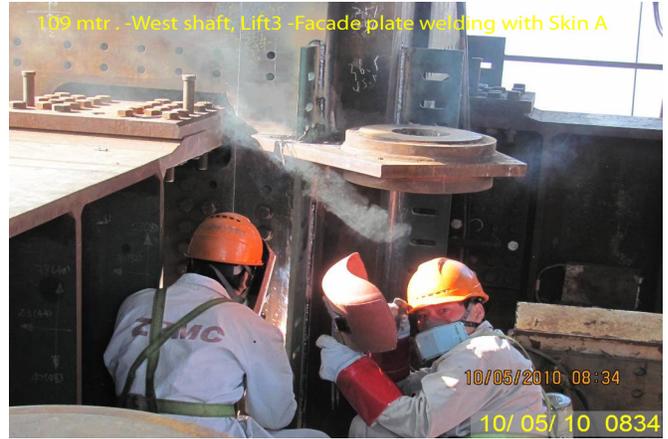
This QA inspector performed (MT) of approximately 15% of an area that has been previously tested and accepted by ZPMC Quality Control (QC) personnel. This QA Inspector generated an TL 6028 MT report for this date. The member is identified as Bike path components. The weld designations reviewed are as follows:

For further information see below pictures:-
