DEPARTMENT OF TRANSPORTATION

Contract #: 04-0120F4Cty: SF/ALA Rte: 80 PM: 13.2/13.9File #: 69.28**WELDING INSPECTION REPORT****Resident Engineer:** Siegenthaler, Peter**Address:** 333 Burma Road**City:** Oakland, CA 94607**Report No:** WIR-017630**Date Inspected:** 28-Oct-2010**Project Name:** SAS Superstructure**OSM Arrival Time:** 700**Prime Contractor:** American Bridge/Fluor Enterprises, a JV**OSM Departure Time:** 1900**Contractor:** Zhenhua Port Machinery Company, Ltd (ZPMC), Changxing Island **Location:** Shanghai, China**CWI Name:** Zhu Zhong Hai.**CWI Present:** Yes No**Inspected CWI report:** Yes No N/A**Rod Oven in Use:** Yes No N/A**Electrode to specification:** Yes No N/A**Weld Procedures Followed:** Yes No N/A**Qualified Welders:** Yes No N/A**Verified Joint Fit-up:** Yes No N/A**Approved Drawings:** Yes No N/A**Approved WPS:** Yes No N/A**Delayed / Cancelled:** Yes No N/A**Bridge No:** 34-0006**Component:** OBG components.**Summary of Items Observed:**

OBG Seg 11AW and Seg 11BW:

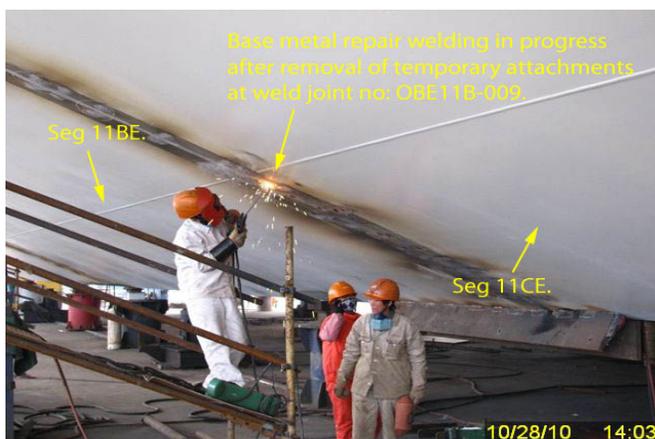
Base metal repair welding after removal of temporary attachments on Side panel at weld joint no: OBE11B-009. The welding process was identified as SMAW. The welder is identified as 050289 and was observed welding in the 4G position. ZPMC QC was identified as Wang Li Yang. The welding variables recorded by QC appeared to comply with WPS: 345-SMAW-4G(4F)-FCM-Repair-1. See attached photo for further details.

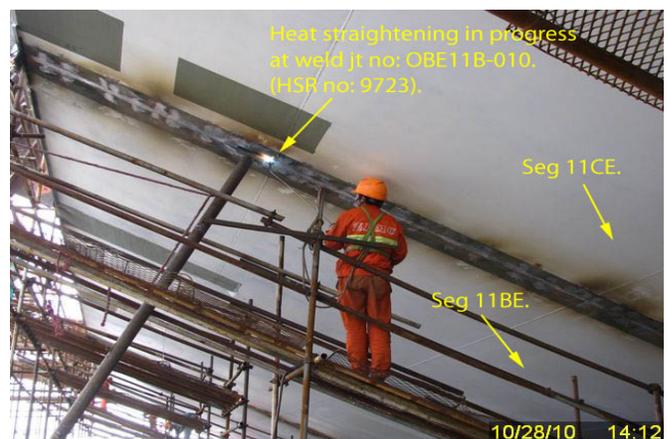
Heat straightening of weld joint no: OBE11B-010. ZPMC QC was identified as Wang Li Yang. Heat straightening was done as per Heat Straightening Report (HSR): HSR(1)-B-9723. See attached photo for further details.
