Contract #: 04-0120F4Cty: SF/ALA Rte: 80 PM: 13.2/13.9File #: 69.28**WELDING INSPECTION REPORT****Resident Engineer:** Siegenthaler, Peter**Address:** 333 Burma Road**City:** Oakland, CA 94607**Report No:** WIR-017714**Date Inspected:** 29-Oct-2010**Project Name:** SAS Superstructure**OSM Arrival Time:** 700**Prime Contractor:** American Bridge/Fluor Enterprises, a JV**OSM Departure Time:** 1900**Contractor:** Zhenhua Port Machinery Company, Ltd (ZPMC), Changxing Island **Location:** Shanghai, China**CWI Name:** Xu Le Feng, Yu Dong Ping**CWI Present:** Yes No**Inspected CWI report:** Yes No N/A**Rod Oven in Use:** Yes No N/A**Electrode to specification:** Yes No N/A**Weld Procedures Followed:** Yes No N/A**Qualified Welders:** Yes No N/A**Verified Joint Fit-up:** Yes No N/A**Approved Drawings:** Yes No N/A**Approved WPS:** Yes No N/A**Delayed / Cancelled:** Yes No N/A**Bridge No:** 34-0006**Component:** OBG/TOWER**Summary of Items Observed:**

WELDING INSPECTION REPORT

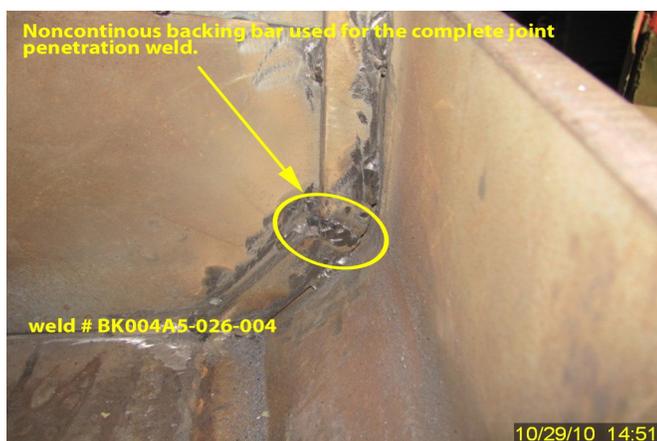
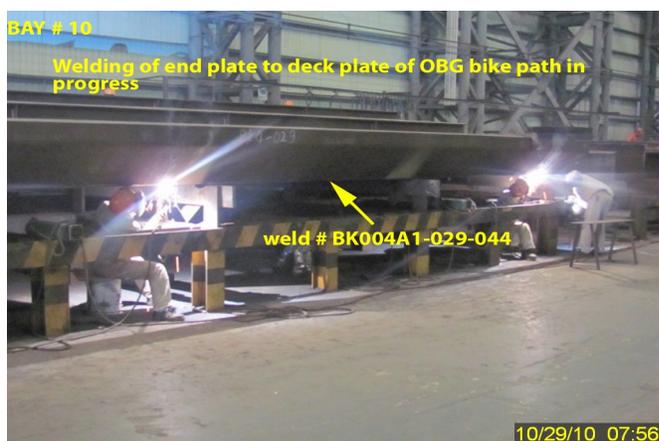
During random in process inspection this QA inspector observed that the fit up for the weld number BK004A5-026-004 of exterior end diaphragm plate to the end plate of OBG bike path has been performed by ZPMC personnel by using noncontinuous steel backing. As per AWS D1.5, Section 3.13.2; Steel backing shall be continuous for the full length of each weld made with backing. This issue discussed with ZPMC CWI Mr. Qiu Wen and ZPMC agreed to replace the noncontinuous steel backing bar with continuous steel backing bar.
