Contract #: 04-0120F4Cty: SF/ALA Rte: 80 PM: 13.2/13.9File #: 69.28**WELDING INSPECTION REPORT****Resident Engineer:** Siegenthaler, Peter**Address:** 333 Burma Road**City:** Oakland, CA 94607**Report No:** WIR-017945**Date Inspected:** 19-Oct-2010**Project Name:** SAS Superstructure**OSM Arrival Time:** 700**Prime Contractor:** American Bridge/Fluor Enterprises, a JV**OSM Departure Time:** 1900**Contractor:** Zhenhua Port Machinery Company, Ltd (ZPMC), Changxing Island **Location:** Shanghai, China**CWI Name:** Xu tao**CWI Present:** Yes No**Inspected CWI report:** Yes No N/A**Rod Oven in Use:** Yes No N/A**Electrode to specification:** Yes No N/A**Weld Procedures Followed:** Yes No N/A**Qualified Welders:** Yes No N/A**Verified Joint Fit-up:** Yes No N/A**Approved Drawings:** Yes No N/A**Approved WPS:** Yes No N/A**Delayed / Cancelled:** Yes No N/A**Bridge No:** 34-0006**Component:** OBG Components**Summary of Items Observed:**

BAY#19

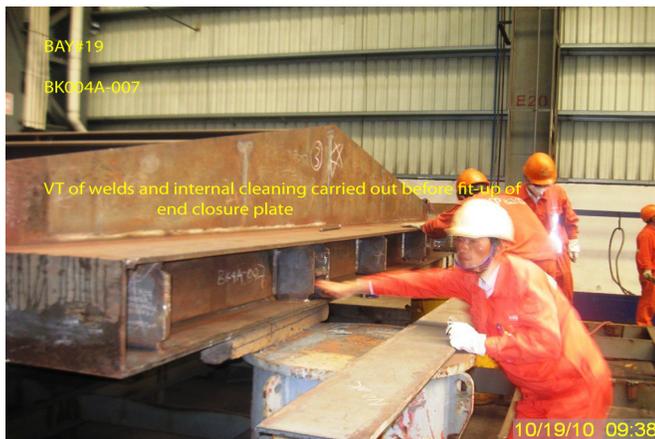
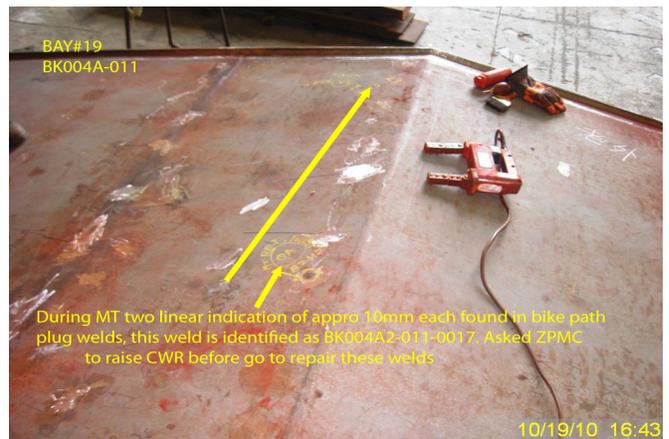
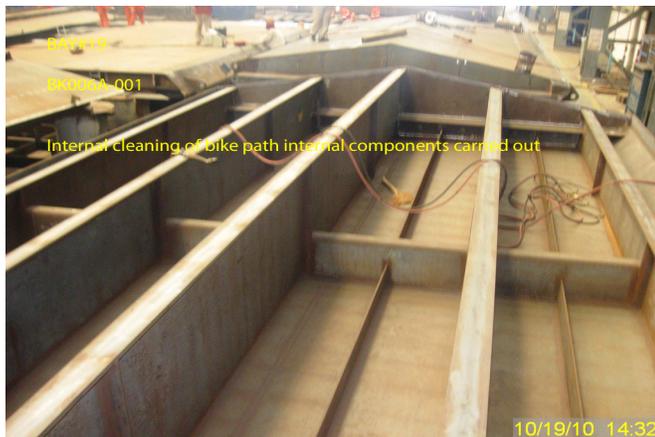
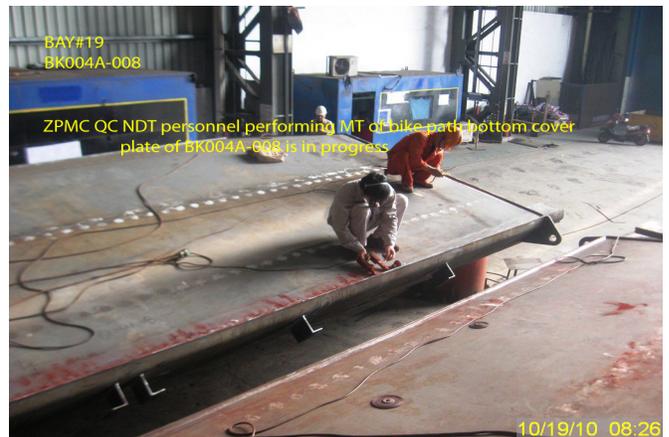
Visual inspection of cleaning of bike path BK004A-007 before fit-up of end closure plate is carried out. Areas requiring additional grinding and cleaning were marked by QA and repaired by ZPMC personnel.

ZPMC QC NDT personnel performing MT of bike path bottom cover plate is identified as BK004A-008.

This QA inspector performed VT of cleanliness of welds and internal areas of Bike path closure box before install the top cover plate BK006A-001. Areas requiring additional grinding and cleaning were marked by QA and repaired by ZPMC personnel.

BK004A2-011-015,017 – 3 reject able indication found in plug welds ask ZPMC to make CWR.
