Contract #: 04-0120F4Cty: SF/ALA Rte: 80 PM: 13.2/13.9File #: 69.28**WELDING INSPECTION REPORT****Resident Engineer:** Siegenthaler, Peter**Address:** 333 Burma Road**City:** Oakland, CA 94607**Report No:** WIR-018006**Date Inspected:** 26-Oct-2010**Project Name:** SAS Superstructure**OSM Arrival Time:** 700**Prime Contractor:** American Bridge/Fluor Enterprises, a JV**OSM Departure Time:** 1900**Contractor:** Zhenhua Port Machinery Company, Ltd (ZPMC), Changxing Island **Location:** Shanghai, China**CWI Name:** Mr. Chen xi**CWI Present:** Yes No**Inspected CWI report:** Yes No N/A**Rod Oven in Use:** Yes No N/A**Electrode to specification:** Yes No N/A**Weld Procedures Followed:** Yes No N/A**Qualified Welders:** Yes No N/A**Verified Joint Fit-up:** Yes No N/A**Approved Drawings:** Yes No N/A**Approved WPS:** Yes No N/A**Delayed / Cancelled:** Yes No N/A**Bridge No:** 34-0006**Component:** Orthotropic Box Girder (OBG)**Summary of Items Observed:**

WELDING INSPECTION REPORT

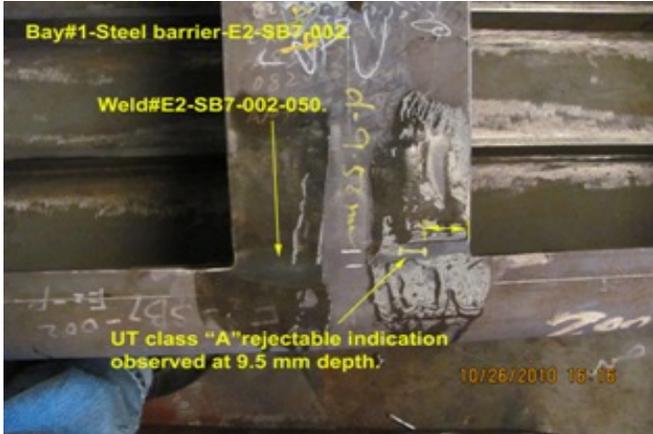
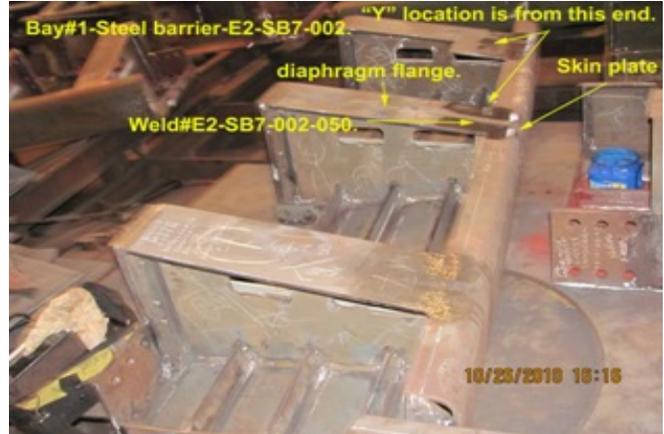
During the QA Ultrasonic Testing (UT) review of weld located on the Steel Barrier (SB) rails, this QA Inspector observed One Class "A" rejectable indication measuring approximately 20 mm in length. The indication rating is +4dB. The depth of the indication was 9.5 mm. The weld joint is identified as E2-SB7-002-050. This weld is a Complete Joint Penetration (CJP) splice joint, joining SB Skin plate to the Diaphragm Flange plate. The thickness of the steel material is 12 mm. The "Y" location is approximately 30 mm from the nearest end of the weld. The indication is clearly marked on or near the weld.

This QA generated an incident report on this date for the above issue, for further information see the incident report and attached photos.
