Quality Assurance and Source Inspection

Contract #: 04-0120F4Cty: SF/ALA Rte: 80 PM: 13.2/13.9File #: 69.28**WELDING INSPECTION REPORT****Resident Engineer:** Siegenthaler, Peter**Address:** 333 Burma Road**City:** Oakland, CA 94607**Report No:** WIR-018416**Date Inspected:** 15-Oct-2010**Project Name:** SAS Superstructure**OSM Arrival Time:** 645**Prime Contractor:** American Bridge/Fluor Enterprises, a JV**OSM Departure Time:** 1845**Contractor:** Zhenhua Port Machinery Company, Ltd (ZPMC), Changxing Island **Location:** Shanghai, China**CWI Name:** Wang Zhu.**CWI Present:** Yes No**Inspected CWI report:** Yes No N/A**Rod Oven in Use:** Yes No N/A**Electrode to specification:** Yes No N/A**Weld Procedures Followed:** Yes No N/A**Qualified Welders:** Yes No N/A**Verified Joint Fit-up:** Yes No N/A**Approved Drawings:** Yes No N/A**Approved WPS:** Yes No N/A**Delayed / Cancelled:** Yes No N/A**Bridge No:** 34-0006**Component:** Orthotropic Box Girder (OBG)**Summary of Items Observed:**

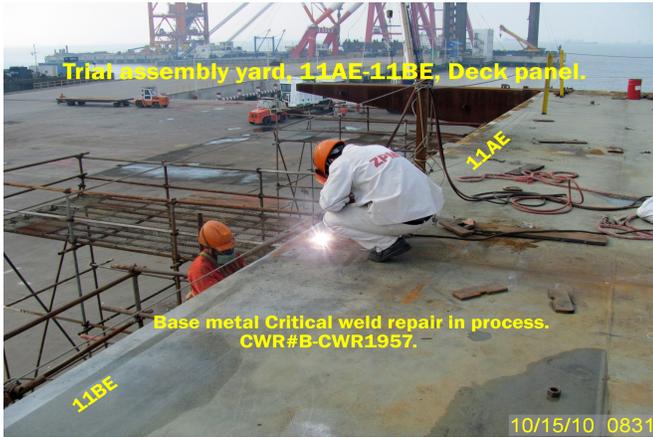
Trial assembly yard, 11AE-11BE, Deck panel.

SMAW Repair welding of Base metal repairs (CWR#B-CWR1957); located at Trial assembly yard. Welder is identified as 044515; ZPMC Quality Control Inspector (QC) is identified as An Qing Xiang. The welding variables recorded by Quality Control Inspector (QC) appeared to comply with the Applicable WPS: WPS-345-SMAW-1G(1F)-FCM-REPAIR-1. The attached photograph provide additional detail.
