Contract #: 04-0120F4Cty: SF/ALA Rte: 80 PM: 13.2/13.9File #: 69.28**WELDING INSPECTION REPORT****Resident Engineer:** Siegenthaler, Peter**Address:** 333 Burma Road**City:** Oakland, CA 94607**Report No:** WIR-018419**Date Inspected:** 18-Oct-2010**Project Name:** SAS Superstructure**OSM Arrival Time:** 645**Prime Contractor:** American Bridge/Fluor Enterprises, a JV**OSM Departure Time:** 1845**Contractor:** Zhenhua Port Machinery Company, Ltd (ZPMC), Changxing Island **Location:** Shanghai, China**CWI Name:** An Qing Xiang.**CWI Present:** Yes No**Inspected CWI report:** Yes No N/A**Rod Oven in Use:** Yes No N/A**Electrode to specification:** Yes No N/A**Weld Procedures Followed:** Yes No N/A**Qualified Welders:** Yes No N/A**Verified Joint Fit-up:** Yes No N/A**Approved Drawings:** Yes No N/A**Approved WPS:** Yes No N/A**Delayed / Cancelled:** Yes No N/A**Bridge No:** 34-0006**Component:** Orthotropic Box Girder (OBG)**Summary of Items Observed:**

WELDING INSPECTION REPORT

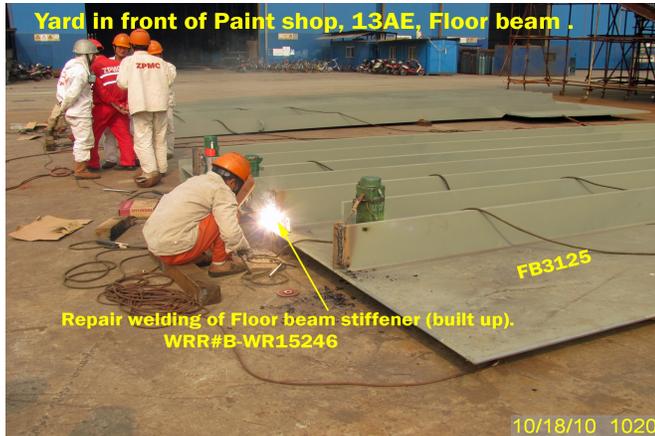
Yard in front of Paint shop, 13AE, Floor beam .

SMAW Repair welding of Floor beam stiffener-built up (WRR#B-WR15246); located at Trial assembly yard. Floor beam identified as FB3125. Welder is identified as 051359; ZPMC Quality Control Inspector (QC) is identified as Li Ping. The welding variables recorded by Quality Control Inspector (QC) appeared to comply with the Applicable WPS: WPS-345-SMAW-3G(3F)-FCM-REPAIR-1. The attached photograph provides additional detail.

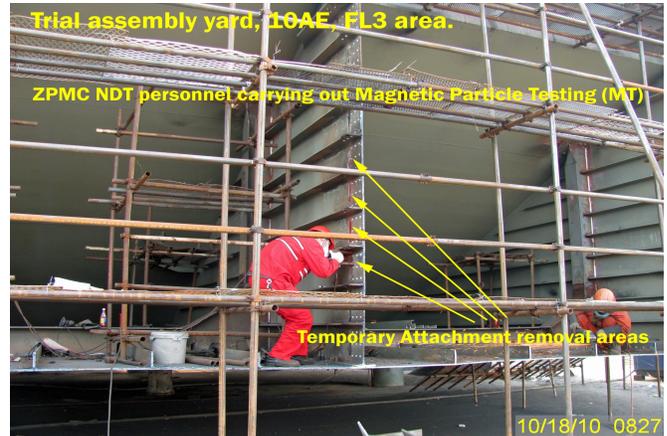
Trial assembly yard, 10AE, FL3 area.

During Random Visual in process Inspection, this QA inspector observed ZPMC NDT personnel “Xie Gen Lin” carrying out Magnetic Particle Testing (MT) on Temporary attachment removal areas at 10AE FL3 area. The attached photographs provide additional detail.
