**DEPARTMENT OF TRANSPORTATION**

Contract #: 04-0120F4Cty: SF/ALA Rte: 80 PM: 13.2/13.9File #: 69.28**WELDING INSPECTION REPORT****Resident Engineer:** Siegenthaler, Peter**Address:** 333 Burma Road**City:** Oakland, CA 94607**Report No:** WIR-017802**Date Inspected:** 03-Nov-2010**Project Name:** SAS Superstructure**OSM Arrival Time:** 1900**Prime Contractor:** American Bridge/Fluor Enterprises, a JV**OSM Departure Time:** 700**Contractor:** Zhenhua Port Machinery Company, Ltd (ZPMC), Changxing Island **Location:** Shanghai, China**CWI Name:** See Below**CWI Present:** Yes No**Inspected CWI report:** Yes No N/A**Rod Oven in Use:** Yes No N/A**Electrode to specification:** Yes No N/A**Weld Procedures Followed:** Yes No N/A**Qualified Welders:** Yes No N/A**Verified Joint Fit-up:** Yes No N/A**Approved Drawings:** Yes No N/A**Approved WPS:** Yes No N/A**Delayed / Cancelled:** Yes No N/A**Bridge No:** 34-0006**Component:** OBG**Summary of Items Observed:**

OBG Bay 13

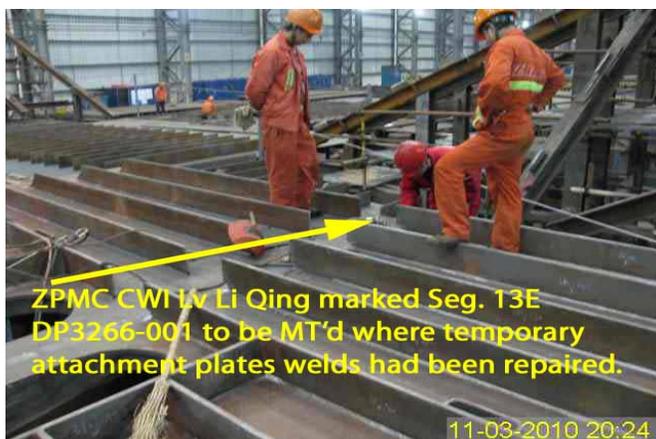
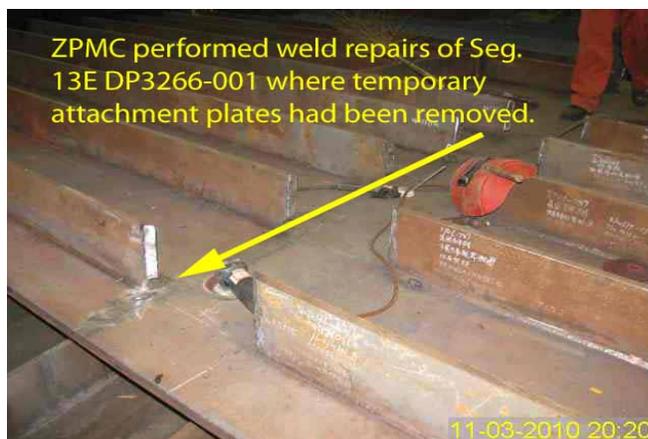
This QA Inspector observed ZPMC welder Mr. Li Yangbing, stencil 208567 used shielded metal arc welding process to make a weld repairs of Segment 13E, deck plate welds DP3266-001-050 and -051 adjacent to where temporary attachment plates had been removed. This QA Inspector asked ZPMC CWI Mr. Lv Li Qing the reason for this weld repair and Mr. Lv Li Qing said this area had been visually rejected after a temporary stiffener plate weld had been removed. This QA Inspector asked Mr. Lv Li Qing if ZPMC will be performing a magnetic particle (MT) inspection of this weld repair area and Mr. Lv Li Qing used a black marker identify that this area is to be MT inspected. See the photographs below for additional information.
