Contract #: 04-0120F4Cty: SF/ALA Rte: 80 PM: 13.2/13.9File #: 69.28**WELDING INSPECTION REPORT****Resident Engineer:** Siegenthaler, Peter**Address:** 333 Burma Road**City:** Oakland, CA 94607**Report No:** WIR-017853**Date Inspected:** 08-Nov-2010**Project Name:** SAS Superstructure**OSM Arrival Time:** 700**Prime Contractor:** American Bridge/Fluor Enterprises, a JV**OSM Departure Time:** 1900**Contractor:** Zhenhua Port Machinery Company, Ltd (ZPMC), Changxing Island **Location:** Shanghai, China**CWI Name:** An Qing Xiang**CWI Present:** Yes No**Inspected CWI report:** Yes No N/A**Rod Oven in Use:** Yes No N/A**Electrode to specification:** Yes No N/A**Weld Procedures Followed:** Yes No N/A**Qualified Welders:** Yes No N/A**Verified Joint Fit-up:** Yes No N/A**Approved Drawings:** Yes No N/A**Approved WPS:** Yes No N/A**Delayed / Cancelled:** Yes No N/A**Bridge No:** 34-0006**Component:** Orthotropic Box Girder (OBG)**Summary of Items Observed:**

OBG TRIAL ASSEMBLY YARD

**WELDING:****Segment 11BW ~ 11CW**

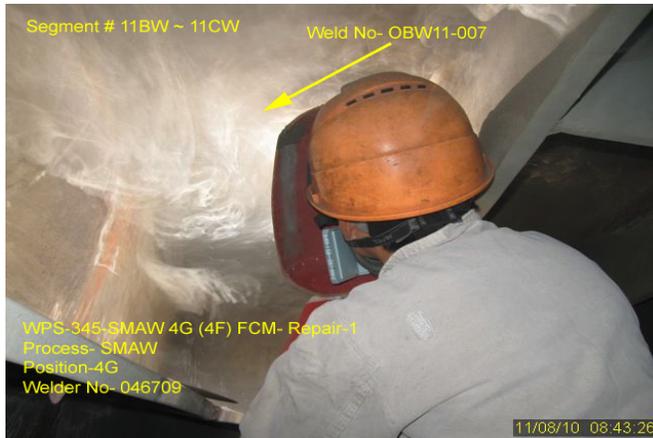
This QA Inspector observed ZPMC qualified welding personnel identified as 046709 perform Shielded Metal Arc Welding (SMAW), weld joint identified as OBE11-007; located On Orthotropic Box Girder (OBG) Deck Plate to Deck Plate Transverse CJP Weld. The Critical Welding Repair Report (CWRR) was B-CWR2178. ZPMC QC is identified as Mr. Zhu Yuan Yuan. The welding parameters measured using QC's calibrated instrument appeared to be in general compliance with applicable WPS-345-SMAW 4G (4F) FCM-Repair-1. See attached photo for further details.

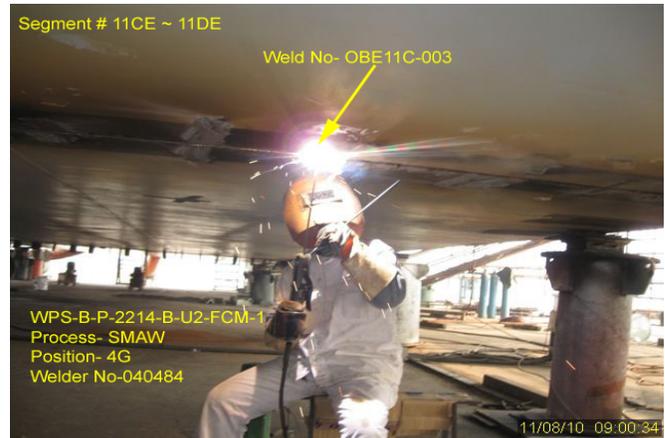
This QA Inspector observed ZPMC qualified welding personnel identified as 040484 perform Shielded Metal Arc Welding (SMAW), weld joint identified as OBE11C-003; located On Orthotropic Box Girder (OBG) Bottom Plate to Bottom Transverse CJP Weld; ZPMC Quality Control (QC) is identified as Mr. Wang Li Yang. The welding variables recorded by QC appeared to comply with applicable WPS-B-P-2214-B-U2-FCM-1. See attached photo for further details.
