Contract #: 04-0120F4Cty: SF/ALA Rte: 80 PM: 13.2/13.9File #: 69.28**WELDING INSPECTION REPORT****Resident Engineer:** Siegenthaler, Peter**Address:** 333 Burma Road**City:** Oakland, CA 94607**Report No:** WIR-017879**Date Inspected:** 06-Nov-2010**Project Name:** SAS Superstructure**OSM Arrival Time:** 645**Prime Contractor:** American Bridge/Fluor Enterprises, a JV**OSM Departure Time:** 1845**Contractor:** Zhenhua Port Machinery Company, Ltd (ZPMC), Changxing Island **Location:** Shanghai, China**CWI Name:** Zhu Zhong Hai.**CWI Present:** Yes No**Inspected CWI report:** Yes No N/A**Rod Oven in Use:** Yes No N/A**Electrode to specification:** Yes No N/A**Weld Procedures Followed:** Yes No N/A**Qualified Welders:** Yes No N/A**Verified Joint Fit-up:** Yes No N/A**Approved Drawings:** Yes No N/A**Approved WPS:** Yes No N/A**Delayed / Cancelled:** Yes No N/A**Bridge No:** 34-0006**Component:** Orthotropic Box Girder (OBG)**Summary of Items Observed:**

WELDING INSPECTION REPORT

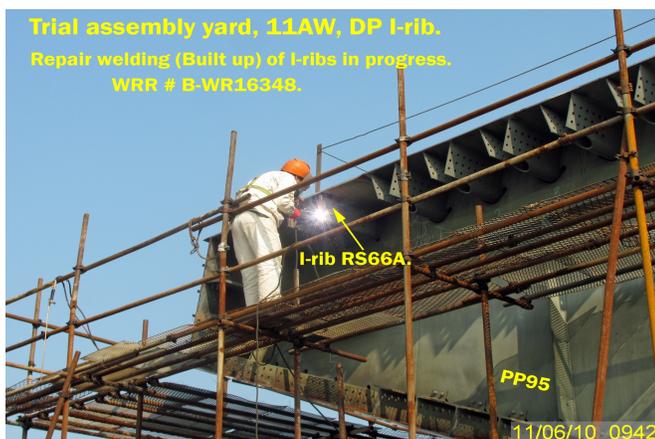
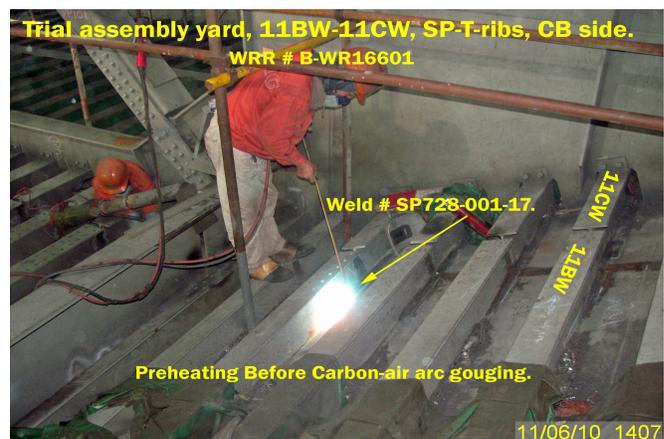
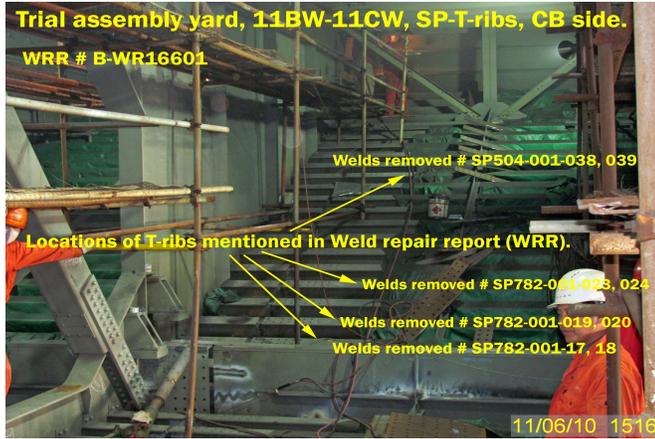
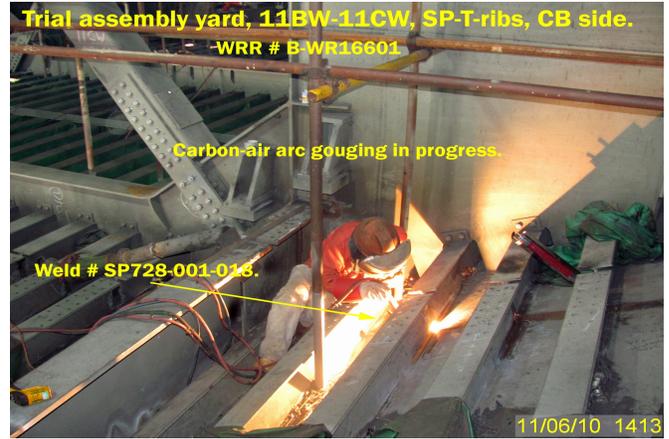
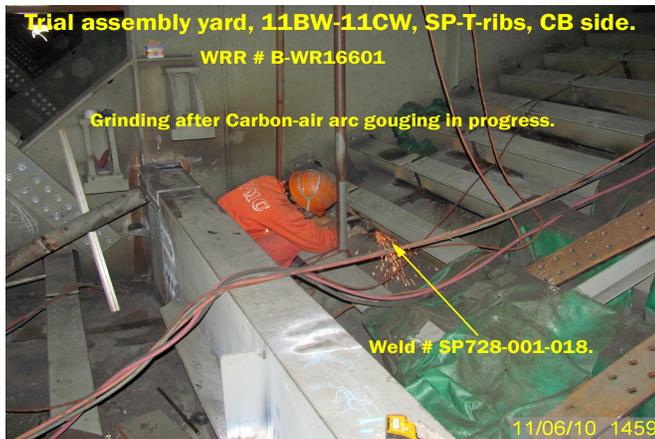
Trial assembly yard, 11AW, PP95, CW side, DP I-rib, Built up.

SMAW Repair welding (Built up) of I-ribs (WRR # B-WR16348); located at Trial assembly yard. Welders are identified as 040667; ZPMC Quality Control Inspector (QC) is identified as Zhu Zhong Hai. The welding variables recorded by Quality Control Inspector (QC) appeared to comply with the Applicable WPS: WPS-345-SMAW-3G(3F)-FCM-REPAIR-1. The attached photographs provide additional detail.

Trial assembly yard, 11BW-11CW, SP-T-ribs, CB side.

Per ZPMC's notification by e-mail dated 11-06-10; ZPMC notified about removing welds off the T-ribs on side panel (Cross beam side) at transverse splice between OBG segment 11BW-11CW. Per ZPMC Weld repair report (WRR # B-WR16601), the Welds were identified as SP728-001-017, 018, 019, 020, 023, 024, 002, 009, 010 & SP504-001-038, 039, 055 (Total 12 Nos.). ZPMC found misaligned T-ribs at above mentioned locations.

On this date this QA inspector witnessed ZPMC removing welds with Carbon –air Arc gouging. Welds identified as SP782-001-017, 018, 019, 020, 023, 024 & SP504-001-038, 039 (T-rib hold back fillet welds). Quality Control Inspector (QC) present was identified as “Zhu Yuan Yuan”. The attached photographs provide additional detail.
