**DEPARTMENT OF TRANSPORTATION**

Contract #: 04-0120F4Cty: SF/ALA Rte: 80 PM: 13.2/13.9File #: 69.28**WELDING INSPECTION REPORT****Resident Engineer:** Siegenthaler, Peter**Address:** 333 Burma Road**City:** Oakland, CA 94607**Report No:** WIR-017912**Date Inspected:** 10-Nov-2010**Project Name:** SAS Superstructure**OSM Arrival Time:** 1900**Prime Contractor:** American Bridge/Fluor Enterprises, a JV**OSM Departure Time:** 700**Contractor:** Zhenhua Port Machinery Company, Ltd (ZPMC), Changxing Island **Location:** Shanghai, China**CWI Name:** See Below**CWI Present:** Yes No**Inspected CWI report:** Yes No N/A**Rod Oven in Use:** Yes No N/A**Electrode to specification:** Yes No N/A**Weld Procedures Followed:** Yes No N/A**Qualified Welders:** Yes No N/A**Verified Joint Fit-up:** Yes No N/A**Approved Drawings:** Yes No N/A**Approved WPS:** Yes No N/A**Delayed / Cancelled:** Yes No N/A**Bridge No:** 34-0006**Component:** OBG**Summary of Items Observed:**

**OBG Bay 12**

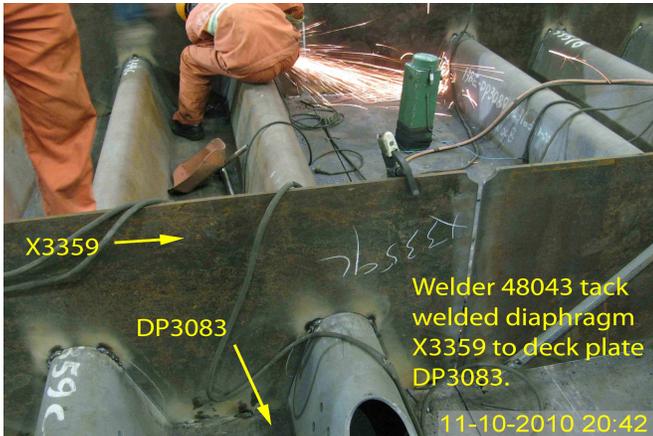
This QA Inspector observed ZPMC welder Mr. Wei Yingchong, stencil 048043 used shielded metal arc welding procedure specification WPS-B-P-2212-FCM-1 to complete tack welds between OBG segment 13BE floor beam diaphragm plate X3184A to deck plate DP3083(PL3184A)-001. This QA Inspector observed Mr. Wei Yingchong appeared to be certified to make this weld, the welding electrodes were stored in a portable rod oven which was warm to the touch and the base materials were preheated with a torch prior to welding. This QA Inspector measured a welding current of approximately 150 amps. Items observed on this date appeared to generally comply with applicable contract documents. See the photograph below for additional information.
