**DEPARTMENT OF TRANSPORTATION**

Contract #: 04-0120F4Cty: SF/ALA Rte: 80 PM: 13.2/13.9File #: 69.28**WELDING INSPECTION REPORT****Resident Engineer:** Siegenthaler, Peter**Address:** 333 Burma Road**City:** Oakland, CA 94607**Report No:** WIR-018023**Date Inspected:** 07-Nov-2010**Project Name:** SAS Superstructure**OSM Arrival Time:** 700**Prime Contractor:** American Bridge/Fluor Enterprises, a JV**OSM Departure Time:** 1900**Contractor:** Zhenhua Port Machinery Company, Ltd (ZPMC), Changxing Island **Location:** Shanghai, China

## WELDING INSPECTION REPORT

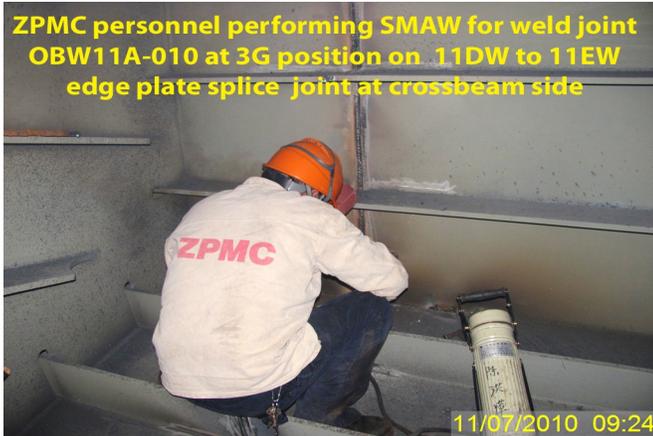
SMAW in the 4G position for the OBG segment 11DW to 11EW, weld No.OBW11A-010.The welder is identified as #044551. ZPMC QC is identified as Mr.Zhu Yuan Yuan. The welding variables recorded by QC appear to comply with WPS-B-P-2213-B-U2-FCM-1.

ZPMC personnel performing SMAW for weld joint OBW11A-010 at 3G position on 11DW to 11EW edge plate splice joint at crossbeam side

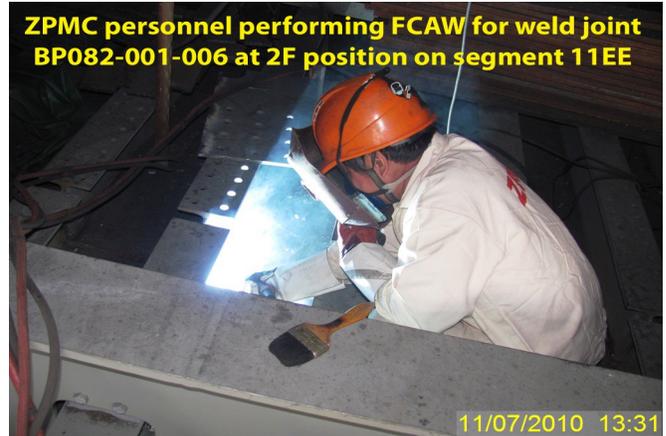
FCAW in the 2F position for the OBG segment 11EE, weld No.BP082-001-006.The welder is identified as #040367. ZPMC QC is identified as Mr. Wang Li Yang . The welding variables recorded by QC appear to comply with WPS-B-T-2132.

ZPMC personnel performing FCAW for weld joint BP082-001-006 at 2F position on segment 11EE

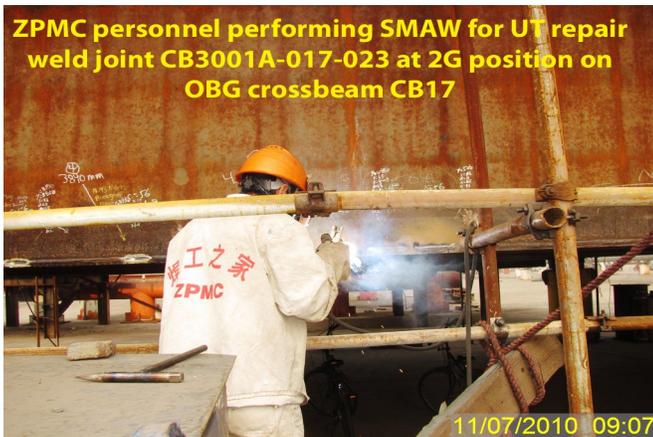
SMAW in the 2G position for the OBG Crossbeam CB17, UT repair weld No.CB3001A-017-023.The welder is identified as #067904. ZPMC QC is identified as Mr. Feng Ya Jun . The welding variables recorded by QC appear to comply with WPS-345-SMAW-2G(2F)-FCM-REPAIR. The weld repair report is identified as WR16620. Green Tagging for service platform component at bay#9

ZPMC personnel performing SMAW for UT repair weld joint CB3001A-017-023 at 2G position on OBG crossbeam CB17

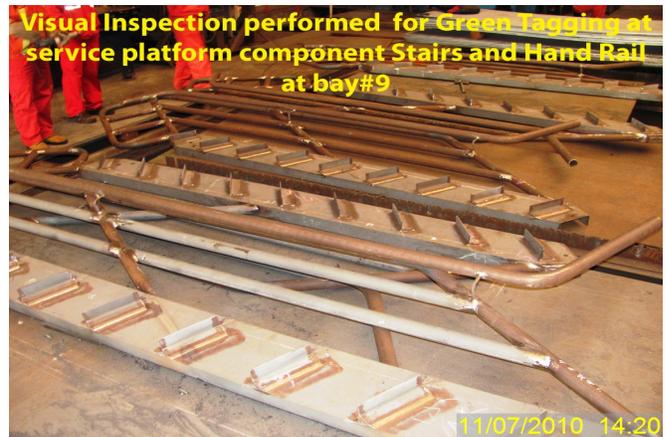
This QA inspector performed Visual Inspection for Green Tagging which were previously tested and accepted by ZPMC Quality Control personnel and ABF QA personnel. The members are identified as service platform component SP4, SP7 and SP8.

Visual Inspection performed for Green Tagging at service platform component Stairs and Hand Rail at bay#9
