**DEPARTMENT OF TRANSPORTATION**

Contract #: 04-0120F4Cty: SF/ALA Rte: 80 PM: 13.2/13.9File #: 69.28**WELDING INSPECTION REPORT****Resident Engineer:** Siegenthaler, Peter**Address:** 333 Burma Road**City:** Oakland, CA 94607**Report No:** WIR-018289**Date Inspected:** 23-Nov-2010**Project Name:** SAS Superstructure**OSM Arrival Time:** 645**Prime Contractor:** American Bridge/Fluor Enterprises, a JV**OSM Departure Time:** 1845**Contractor:** Zhenhua Port Machinery Company, Ltd (ZPMC), Changxing Island **Location:** Shanghai, China**CWI Name:** Zhu Zhong Hai.**CWI Present:** Yes No**Inspected CWI report:** Yes No N/A**Rod Oven in Use:** Yes No N/A**Electrode to specification:** Yes No N/A**Weld Procedures Followed:** Yes No N/A**Qualified Welders:** Yes No N/A**Verified Joint Fit-up:** Yes No N/A**Approved Drawings:** Yes No N/A**Approved WPS:** Yes No N/A**Delayed / Cancelled:** Yes No N/A**Bridge No:** 34-0006**Component:** Orthotropic Box Girder (OBG)**Summary of Items Observed:**

# WELDING INSPECTION REPORT

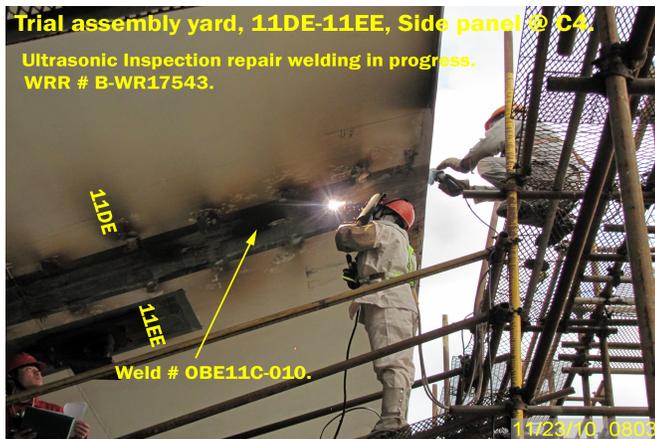
SMAW Repair welding (Ultrasonic Inspection repair per ZPMC UT-report # UT-11E-064) of weld joint OBE11C-010 (WRR # B-WR17543); located at Trial assembly yard. Welder is identified as 053871; ZPMC Quality Control Inspector (QC) is identified as An Qing Xiang. The welding variables recorded by Quality Control Inspector (QC) appeared to comply with the Applicable WPS: WPS-345-SMAW-4G(4F)-FCM-REPAIR-1. The attached photographs provide additional detail.
