Quality Assurance and Source Inspection

Contract #: 04-0120F4Cty: SF/ALA Rte: 80 PM: 13.2/13.9File #: 69.28**WELDING INSPECTION REPORT****Resident Engineer:** Siegenthaler, Peter**Address:** 333 Burma Road**City:** Oakland, CA 94607**Report No:** WIR-018319**Date Inspected:** 25-Nov-2010**Project Name:** SAS Superstructure**OSM Arrival Time:** 700**Prime Contractor:** American Bridge/Fluor Enterprises, a JV**OSM Departure Time:** 1900**Contractor:** Zhenhua Port Machinery Company, Ltd (ZPMC), Changxing Island **Location:** Shanghai, China**CWI Name:** Liu Fa Wen**CWI Present:** Yes No**Inspected CWI report:** Yes No N/A**Rod Oven in Use:** Yes No N/A**Electrode to specification:** Yes No N/A**Weld Procedures Followed:** Yes No N/A**Qualified Welders:** Yes No N/A**Verified Joint Fit-up:** Yes No N/A**Approved Drawings:** Yes No N/A**Approved WPS:** Yes No N/A**Delayed / Cancelled:** Yes No N/A**Bridge No:** 34-0006**Component:** OBG**Summary of Items Observed:**

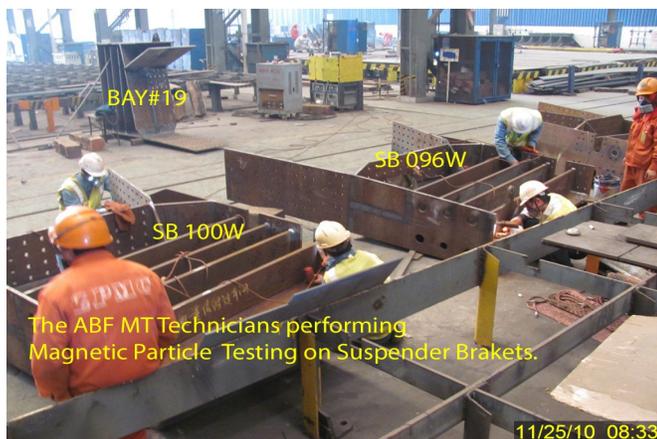
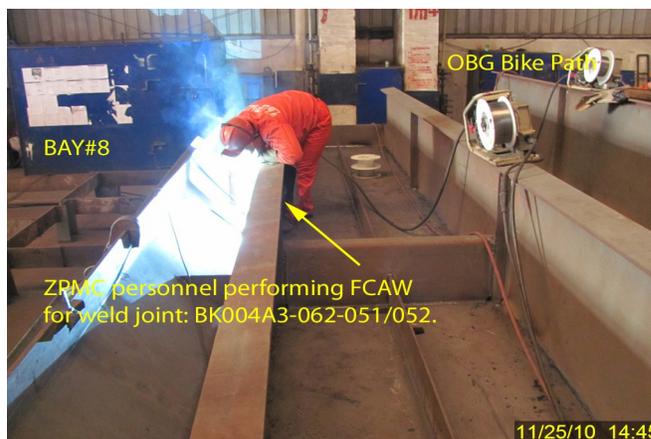
FCAW in the 2F position for the OBG Segment Bike Path, The weld joint was designated as: BK004A3-062-051/052. The welder is identified as #042218. ZPMC CWI is identified as Mr. Liu Fa Wen. The welding variables recorded by QC appear to comply with WPS-B-T-2132. Please see the attached picture.
