Contract #: 04-0120F4Cty: SF/ALA Rte: 80 PM: 13.2/13.9File #: 69.28**WELDING INSPECTION REPORT****Resident Engineer:** Siegenthaler, Peter**Address:** 333 Burma Road**City:** Oakland, CA 94607**Report No:** WIR-018553**Date Inspected:** 10-Dec-2010**Project Name:** SAS Superstructure**OSM Arrival Time:** 700**Prime Contractor:** American Bridge/Fluor Enterprises, a JV**OSM Departure Time:** 1900**Contractor:** Zhenhua Port Machinery Company, Ltd (ZPMC), Changxing Island **Location:** Shanghai, China**CWI Name:** Geng Wei**CWI Present:** Yes No**Inspected CWI report:** Yes No N/A**Rod Oven in Use:** Yes No N/A**Electrode to specification:** Yes No N/A**Weld Procedures Followed:** Yes No N/A**Qualified Welders:** Yes No N/A**Verified Joint Fit-up:** Yes No N/A**Approved Drawings:** Yes No N/A**Approved WPS:** Yes No N/A**Delayed / Cancelled:** Yes No N/A**Bridge No:** 34-0006**Component:** OBG**Summary of Items Observed:**

WELDING INSPECTION REPORT

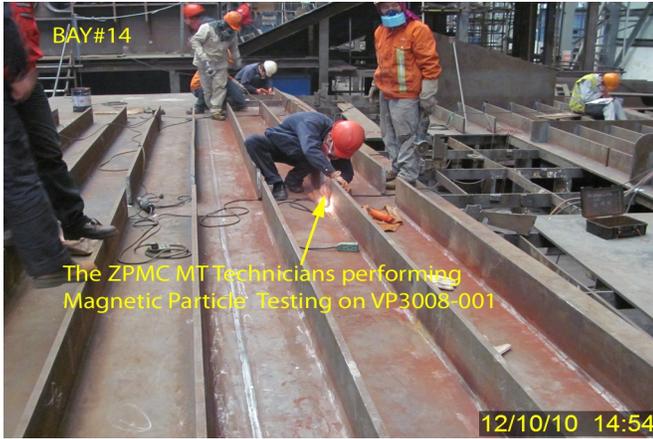
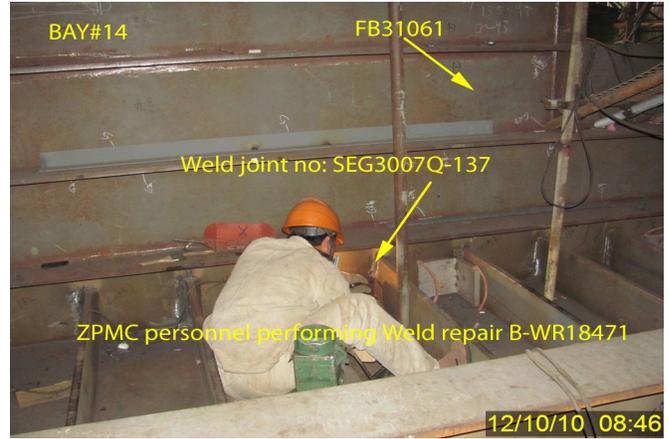
SMAW welding of weld joint no: SEG3007Q-137 located on OBG Segment Bottom panel stiffener to FB3106. Welder is identified as #215553. ZPMC CWI is identified as Mr. Lv Li Qing. Welding was performed according to the weld repair report B-WR18471 and UT report number: B787-UT-18366. The welding variables recorded by QC appeared to comply with the WPS-345-SMAW-3G(3F)-Repair. Please see the attached picture.
