Contract #: 04-0120F4Cty: SF/ALA Rte: 80 PM: 13.2/13.9File #: 69.28**WELDING INSPECTION REPORT****Resident Engineer:** Siegenthaler, Peter**Address:** 333 Burma Road**City:** Oakland, CA 94607**Report No:** WIR-018734**Date Inspected:** 12-Dec-2010**Project Name:** SAS Superstructure**OSM Arrival Time:** 700**Prime Contractor:** American Bridge/Fluor Enterprises, a JV**OSM Departure Time:** 1900**Contractor:** Zhenhua Port Machinery Company, Ltd (ZPMC), Changxing Island **Location:** Shanghai, China**CWI Name:** Mr. Zhu Zhong Hai.**CWI Present:** Yes No**Inspected CWI report:** Yes No N/A**Rod Oven in Use:** Yes No N/A**Electrode to specification:** Yes No N/A**Weld Procedures Followed:** Yes No N/A**Qualified Welders:** Yes No N/A**Verified Joint Fit-up:** Yes No N/A**Approved Drawings:** Yes No N/A**Approved WPS:** Yes No N/A**Delayed / Cancelled:** Yes No N/A**Bridge No:** 34-0006**Component:** Orthotropic Box Girder (OBG)**Summary of Items Observed:**

OBG TRAL ASSEMBLY

OBG Segment 12AE-12BE

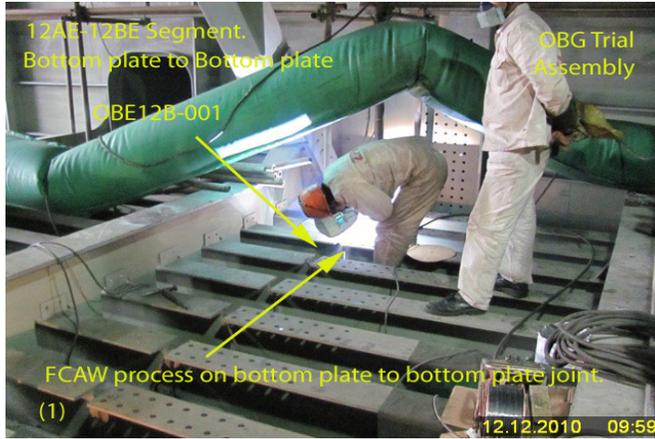
This QA Inspector observed ZPMC qualified welding personnel identified as 047353, 040458 Perform Flux Core Arc Welding (FCAW) on OBG segment 12AE + 12BE Bottom plate to Bottom plate joint. Joint identified as OBE12B-001. ZPMC QC Identified as Wang Li Yang. The welding parameters as measured using QC's calibrated instrument appeared to be in general compliance with WPS-B-T-2231-T-ESAB. For more information see below attached picture number 1.

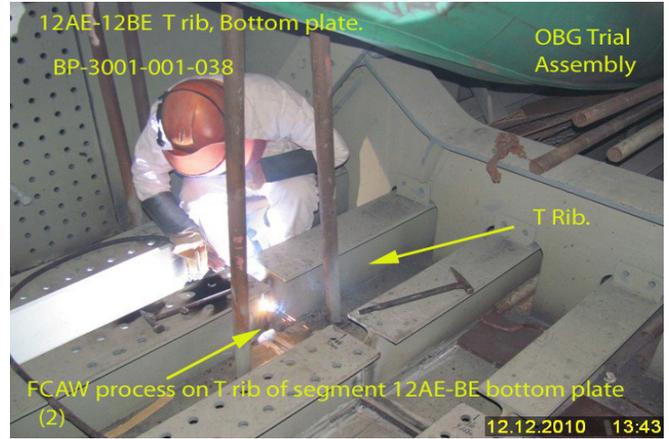
This QA Inspector observed ZPMC qualified welding personnel identified as 040367 Perform Flux Core Arc Welding (FCAW) on OBG segment 12AE + 12BE "T" rib of bottom plate. Joint identified as BP3001-001-038. ZPMC QC Identified as Wang Li Yang. The welding parameters as measured using QC's calibrated instrument appeared to be in general compliance with WPS-B-T-2233-ESAB. For more information see below attached picture number 2.
