Contract #: 04-0120F4Cty: SF/ALA Rte: 80 PM: 13.2/13.9File #: 99.28**WELDING INSPECTION REPORT****Resident Engineer:** Siegenthaler, Peter**Address:** 333 Burma Road**City:** Oakland, CA 94607**Report No:** WIR-018881**Date Inspected:** 22-Dec-2010**Project Name:** SAS Superstructure**OSM Arrival Time:** 700**Prime Contractor:** American Bridge/Fluor Enterprises, a JV**OSM Departure Time:** 1900**Contractor:** Zhenhua Port Machinery Company, Ltd (ZPMC)**Location:** Shanghai, China**CWI Name:** Li Yang and Zhu Zhong Hai**CWI Present:** Yes No**Inspected CWI report:** Yes No N/A**Rod Oven in Use:** Yes No N/A**Electrode to specification:** Yes No N/A**Weld Procedures Followed:** Yes No N/A**Qualified Welders:** Yes No N/A**Verified Joint Fit-up:** Yes No N/A**Approved Drawings:** Yes No N/A**Approved WPS:** Yes No N/A**Delayed / Cancelled:** Yes No N/A**Bridge No:** 34-0006**Component:** OBG Trial Assembly**Summary of Items Observed:**

Orthotropic Box Girder (OBG) at Trial Assembly Areas

WELDING INSPECTION REPORT

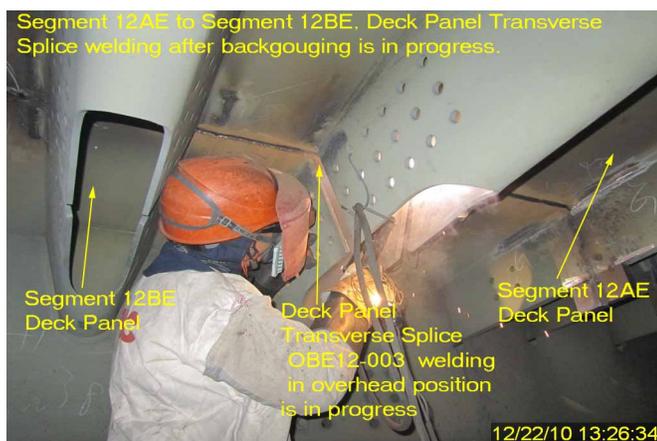
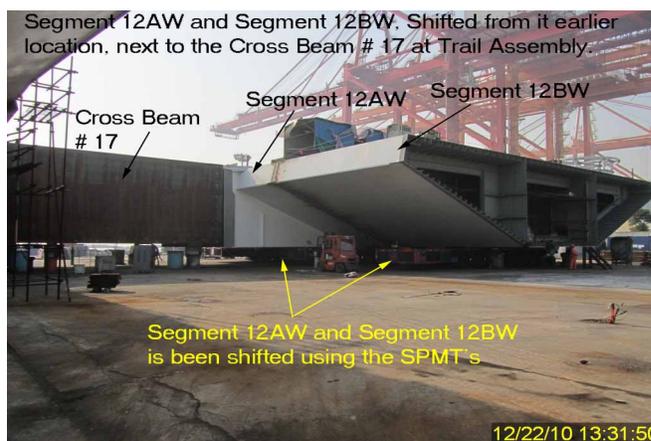
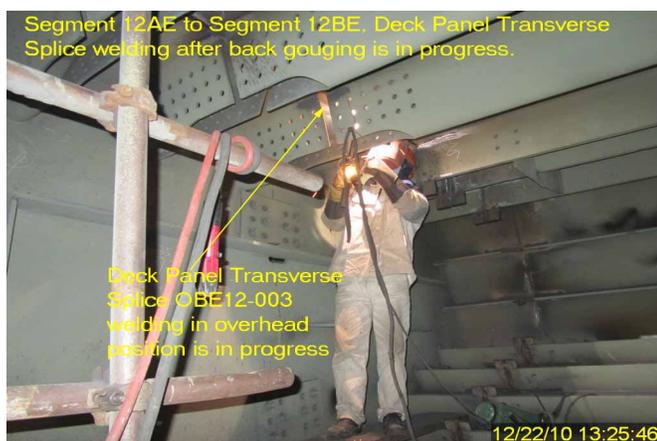
This QA Inspector observed the in-process welding by Shielded Metal Arc Welding (SMAW) process on a Complete Joint Penetration (CJP) groove weld. The Weld joint was designated as OBE12-003. The welder identification was 045515 observed welding in the 4G (Overhead) position using approved Welding Procedure Specification WPS-B-P-2214-B-U2-FCM-1. The piece mark was identified as the Deck Panel at transverse splice.

This QA Inspector observed the in-process welding by Shielded Metal Arc Welding (SMAW) process on a Complete Joint Penetration (CJP) groove weld. The Weld joint was designated as CA6502-009. The welder identification was 045515 observed welding in the 4G (Overhead) position using approved Welding Procedure Specification WPS-B-P-2214-B-U2-FCM-1. The piece mark was identified as the Deck Panel Corner Assembly, Bike Path side at transverse splice.

This QA Inspector observed the Segment 12AW and Segment 12BW which is welded together been shifted from its earlier location, next to Cross Beam # 17 at Trial Assembly Area. Cross Beam # 17 is sitting next to Segment 12AE FL3 extension area.
