**DEPARTMENT OF TRANSPORTATION**

Contract #: 04-0120F4Cty: SF/ALA Rte: 80 PM: 13.2/13.9File #: 69.28**WELDING INSPECTION REPORT****Resident Engineer:** Siegenthaler, Peter**Address:** 333 Burma Road**City:** Oakland, CA 94607**Report No:** WIR-019141**Date Inspected:** 08-Jan-2011**Project Name:** SAS Superstructure**OSM Arrival Time:** 700**Prime Contractor:** American Bridge/Fluor Enterprises, a JV**OSM Departure Time:** 1900**Contractor:** Zhenhua Port Machinery Company, Ltd (ZPMC), Changxing Island **Location:** Shanghai, China**CWI Name:** Liu Hua Jie**CWI Present:** Yes No**Inspected CWI report:** Yes No N/A**Rod Oven in Use:** Yes No N/A**Electrode to specification:** Yes No N/A**Weld Procedures Followed:** Yes No N/A**Qualified Welders:** Yes No N/A**Verified Joint Fit-up:** Yes No N/A**Approved Drawings:** Yes No N/A**Approved WPS:** Yes No N/A**Delayed / Cancelled:** Yes No N/A**Bridge No:** 34-0006**Component:** Orthotropic Box Girder (OBG)**Summary of Items Observed:**

**WELDING:****Segment 12BW**

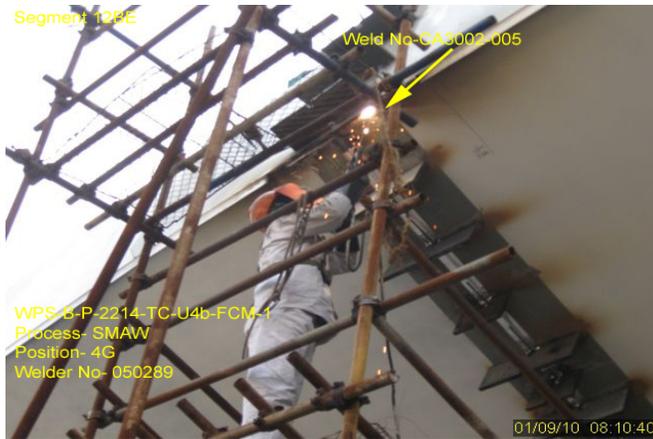
This QA Inspector observed ZPMC qualified welding personnel identified as 046704 perform Shielded Metal Arc Welding (SMAW), weld joint identified as SEG3005M-90; located On Orthotropic Box Girder (OBG) Bottom Plate to Bottom Plate CJP Weld; The Welding Repair Report (WRR) was B-WR20086. ZPMC Quality Control (QC) is identified as Mr. Shi Lei. The welding variables recorded by QC appeared to comply with applicable WPS-345-SMAW 2G (2F) FCM-Repair-1. See attached photo for further details.

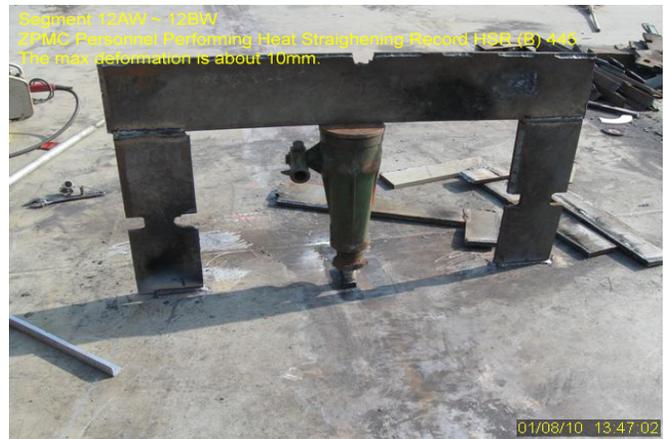
ZPMC personnel heat straightening Orthotropic Box Girder (OBG) member identified as Segment 12AW ~ 12BW Deck Plate to Deck Plate Transverse Splice CJP Weld. Distortion appeared to be caused by Welding. ZPMC Quality Control (QC) inspector identified as Mr. Zhou Peng was present to monitor the heat straightening process. The heat straightening appeared to comply with Heat Straightening Report HSR (B) 445. See attached photo for further details.
