DEPARTMENT OF TRANSPORTATION

Contract #: 04-0120F4Cty: SF/ALA Rte: 80 PM: 13.2/13.9File #: 69.28**WELDING INSPECTION REPORT****Resident Engineer:** Siegenthaler, Peter**Address:** 333 Burma Road**City:** Oakland, CA 94607**Report No:** WIR-019687**Date Inspected:** 18-Jan-2011**Project Name:** SAS Superstructure**OSM Arrival Time:** 700**Prime Contractor:** American Bridge/Fluor Enterprises, a JV**OSM Departure Time:** 1900**Contractor:** Zhenhua Port Machinery Company, Ltd (ZPMC), Changxing Island **Location:** Shanghai, China**CWI Name:** Mr. Xu Le Feng.**CWI Present:** Yes No**Inspected CWI report:** Yes No N/A**Rod Oven in Use:** Yes No N/A**Electrode to specification:** Yes No N/A**Weld Procedures Followed:** Yes No N/A**Qualified Welders:** Yes No N/A**Verified Joint Fit-up:** Yes No N/A**Approved Drawings:** Yes No N/A**Approved WPS:** Yes No N/A**Delayed / Cancelled:** Yes No N/A**Bridge No:** 34-0006**Component:** Tower and Orthotropic Box Girder (OBG)**Summary of Items Observed:**

WELDING INSPECTION REPORT

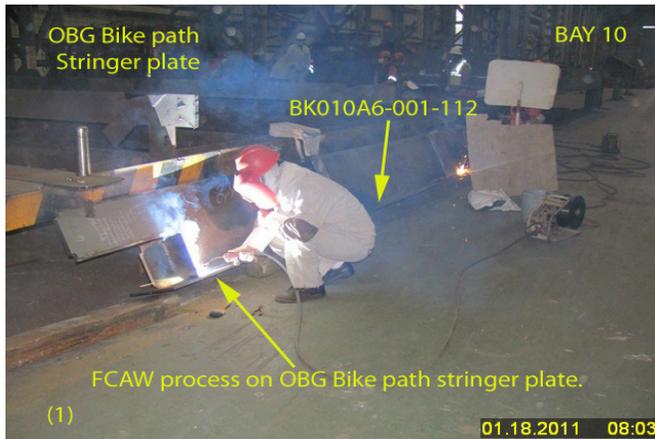
This QA Inspector observed ZPMC qualified welding personnel identified as 040533, 053869, Perform Flux Core Arc Welding (FCAW) on OBG Bike Path Stringer plate. Joint identified as BK010A6-001-112, ZPMC QC Identified as Yu Zhi Lai. The welding parameters as measured using QC's calibrated instrument appeared to be in general compliance with WPS-B-T-2132-ESAB. For more information see attached picture number 1.

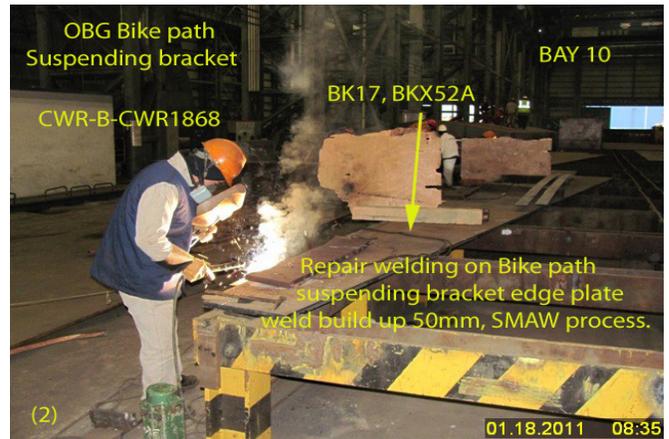
This QA Inspector observed ZPMC qualified welding personnel identified as 040582, 057220, 040581, Perform Shielded Metal Arc Welding (SMAW) on OBG Bike path suspending bracket edge plate. Plate identified as BKX52A weld build up 50mm. ZPMC QC Identified as Li Peng Fei with critical welding repair report CWR-B-CWR1868. The welding parameters as measured using QC's calibrated instrument appeared to be in general compliance with WPS-345-SMAW-2G (2F) Repair. For more information see attached picture number 2.
