**DEPARTMENT OF TRANSPORTATION**

Contract #: 04-0120F4Cty: SF/ALA Rte: 80 PM: 13.2/13.9File #: 99.28**WELDING INSPECTION REPORT****Resident Engineer:** Siegenthaler, Peter**Address:** 333 Burma Road**City:** Oakland, CA 94607**Report No:** WIR-020074**Date Inspected:** 28-Jan-2011**Project Name:** SAS Superstructure**OSM Arrival Time:** 700**Prime Contractor:** American Bridge/Fluor Enterprises, a JV**OSM Departure Time:** 1900**Contractor:** Zhenhua Port Machinery Company, Ltd (ZPMC) Chanxing Island**Location:** Shanghai, China**CWI Name:** Mr. Qui Wen**CWI Present:** Yes No**Inspected CWI report:** Yes No N/A**Rod Oven in Use:** Yes No N/A**Electrode to specification:** Yes No N/A**Weld Procedures Followed:** Yes No N/A**Qualified Welders:** Yes No N/A**Verified Joint Fit-up:** Yes No N/A**Approved Drawings:** Yes No N/A**Approved WPS:** Yes No N/A**Delayed / Cancelled:** Yes No N/A**Bridge No:** 34-0006**Component:** OBG Segment**Summary of Items Observed:**

## WELDING INSPECTION REPORT

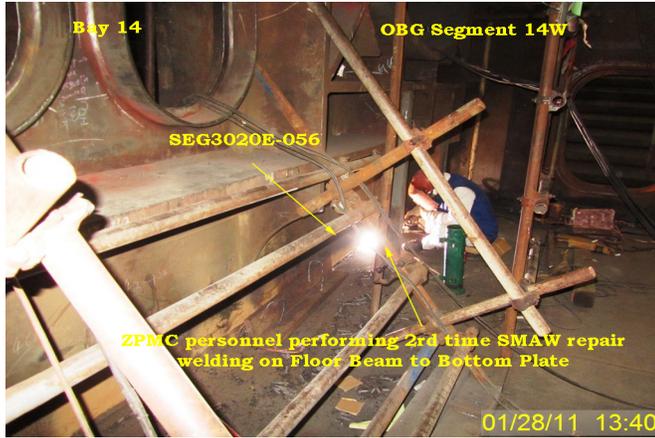
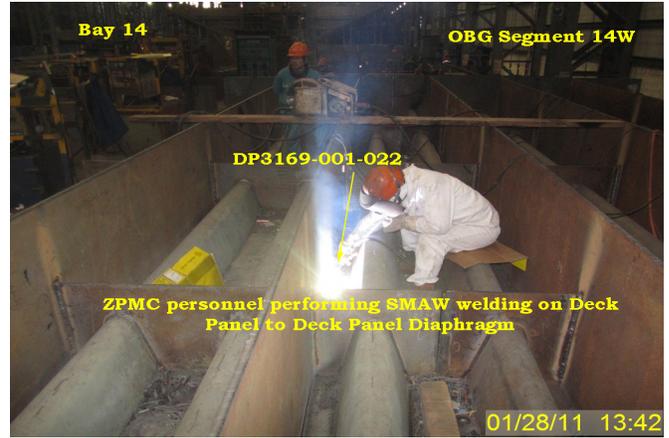
Shielded Metal Arc Welding (SMAW) repair welding of weld joint SEG3020D-052 located on Floor Beam to Bottom Plate at panel point 128.3 of OBG Segment 14W. ZPMC Welders are identified as 066038. ZPMC Quality Control (QC) is identified as Mr. Zhu Lin. The welding variables recorded by QC appeared to comply with the Applicable WPS-345-SMAW-2G (2F) – FCM – Repair, which is used as per Critical Welding Repair (CWR) B-CWR-2734-R1.

SMAW repair welding of weld joint SEG3020E-056 located on Floor Beam to Bottom Plate at panel point 128.3 of OBG Segment 14W. ZPMC Welders are identified as 066398. ZPMC Quality Control (QC) is identified as Mr. Zhu Lin. The welding variables recorded by QC appeared to comply with the Applicable WPS-345-SMAW-2G (2F) – FCM – Repair, which is used as per Critical Welding Repair (CWR) B-CWR-2734-R1.
