**DEPARTMENT OF TRANSPORTATION**

Contract #: 04-0120F4Cty: SF/ALA Rte: 80 PM: 13.2/13.9File #: 69.28**WELDING INSPECTION REPORT****Resident Engineer:** Siegenthaler, Peter**Address:** 333 Burma Road**City:** Oakland, CA 94607**Report No:** WIR-020271**Date Inspected:** 05-Feb-2011**Project Name:** SAS Superstructure**OSM Arrival Time:** 700**Prime Contractor:** American Bridge/Fluor Enterprises, a JV**OSM Departure Time:** 1700**Contractor:** Zhenhua Port Machinery Company, Ltd (ZPMC), Changxing Island **Location:** Shanghai, China**CWI Name:** Qiu Wen.**CWI Present:** Yes No**Inspected CWI report:** Yes No N/A**Rod Oven in Use:** Yes No N/A**Electrode to specification:** Yes No N/A**Weld Procedures Followed:** Yes No N/A**Qualified Welders:** Yes No N/A**Verified Joint Fit-up:** Yes No N/A**Approved Drawings:** Yes No N/A**Approved WPS:** Yes No N/A**Delayed / Cancelled:** Yes No N/A**Bridge No:** 34-0006**Component:** OBG components.**Summary of Items Observed:**

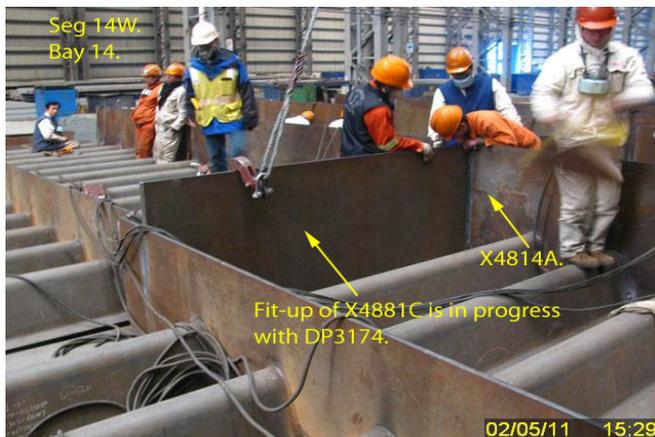
This QA Inspector observed ZPMC personnel performing fit-up of X4881C with DP3174. ABF QA was identified as Shen Jian. See attached photo for further details.
