Contract #: 04-0120F4Cty: SF/ALA Rte: 80 PM: 13.2/13.9File #: 99.28**WELDING INSPECTION REPORT****Resident Engineer:** Siegenthaler, Peter**Address:** 333 Burma Road**City:** Oakland, CA 94607**Report No:** WIR-020723**Date Inspected:** 11-Feb-2011**Project Name:** SAS Superstructure**OSM Arrival Time:** 700**Prime Contractor:** American Bridge/Fluor Enterprises, a JV**OSM Departure Time:** 1900**Contractor:** Zhenhua Port Machinery Company, Ltd (ZPMC) Chanxing Island**Location:** Shanghai, China

WELDING INSPECTION REPORT

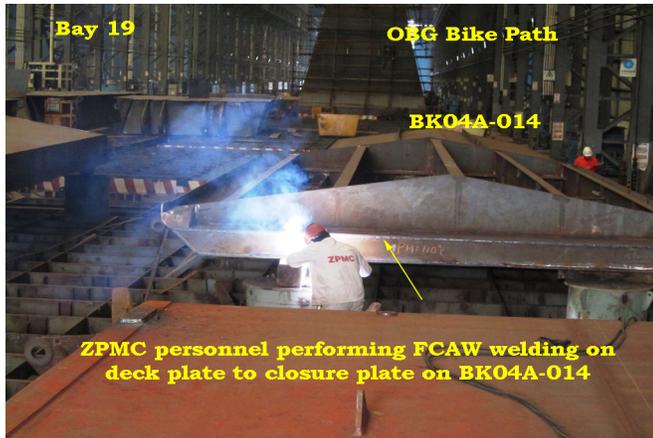
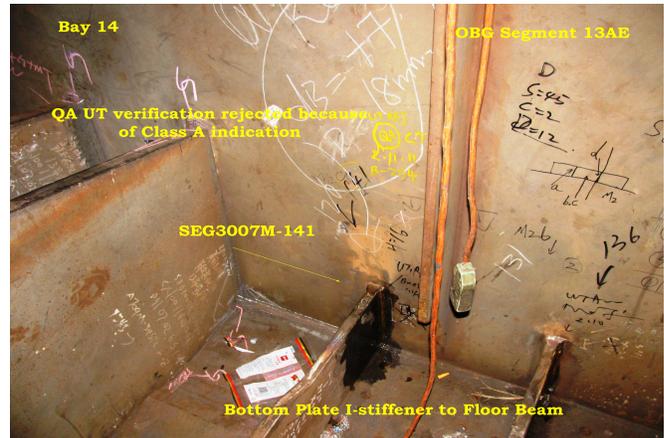
FCAW welding of weld joint BK004A6-014-001 and 165 located on OBG Bike Path. ZPMC Welder is identified as 062735. ZPMC Quality Control (QC) is identified as Mr. Guo Xing Hui. The welding variables recorded by QC appeared to comply with the Applicable WPS-B-T-2232(3)-ESAB. See the attached picture.
